### Underwater Inspection Report for:

Highland Road Over the Cuyahoga River, Summit County, Ohio

(Prestressed Concrete Box Beams on Capped Pile Bents and Abutments)

Report Prepared Date: June 12, 2026

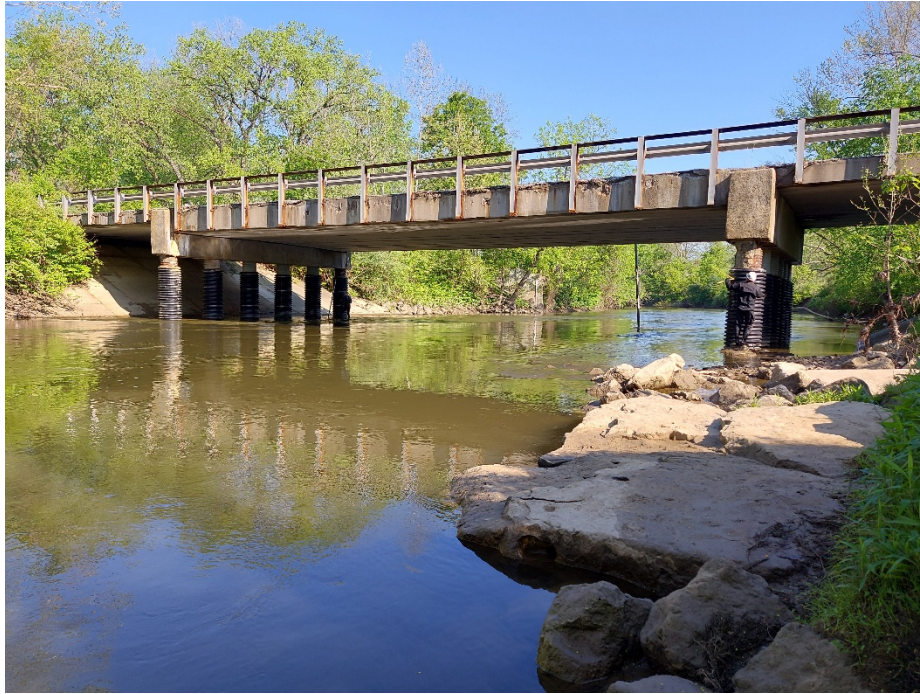
*Photo 1 – Facing northwest - South elevation of the bridge.*

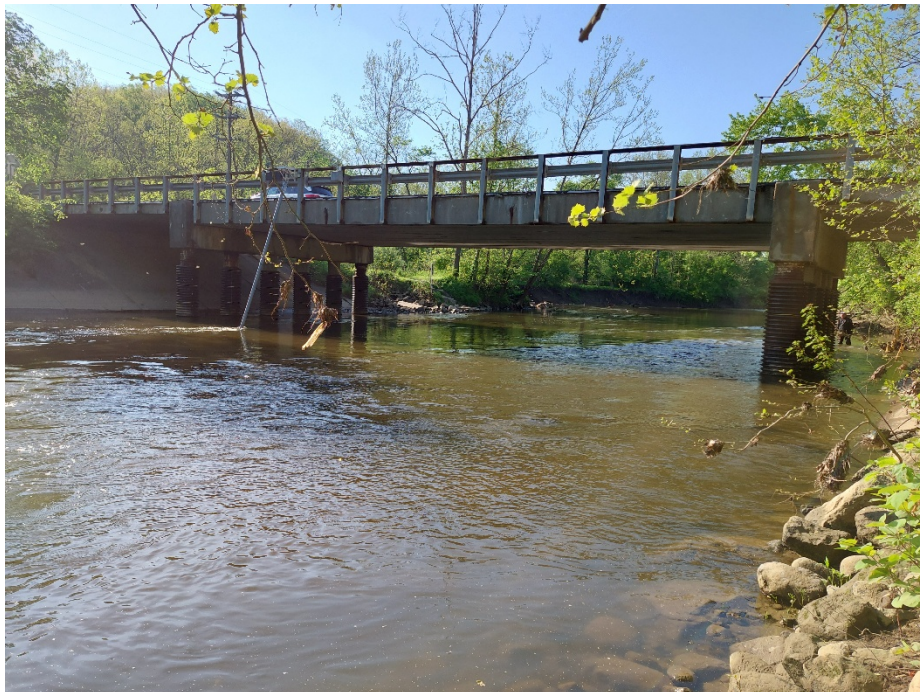
*Photo 2 – Facing southeast - North elevation of the bridge.*

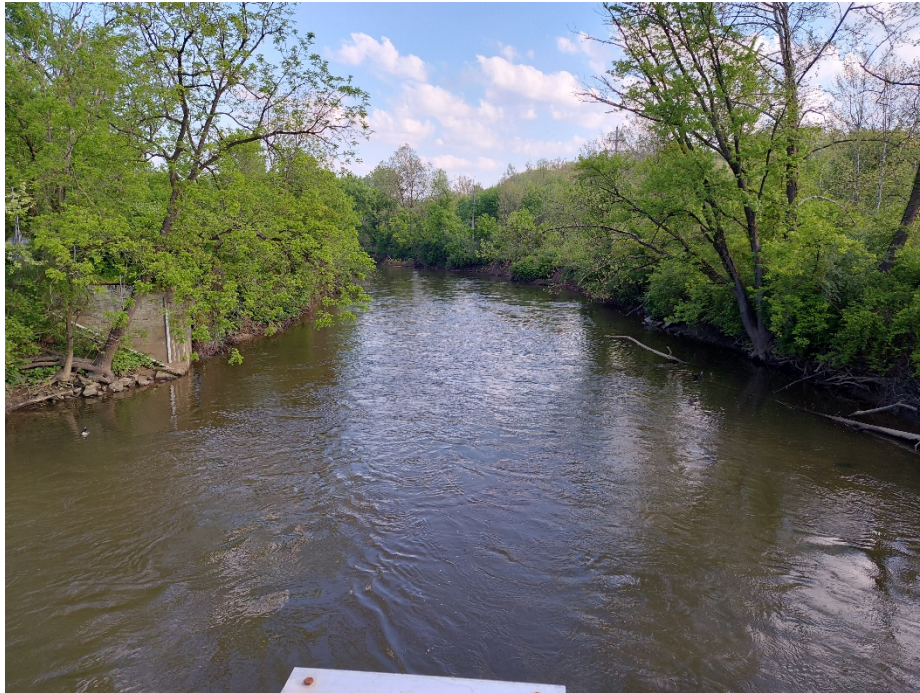
*Photo 3 – Facing north downstream.*

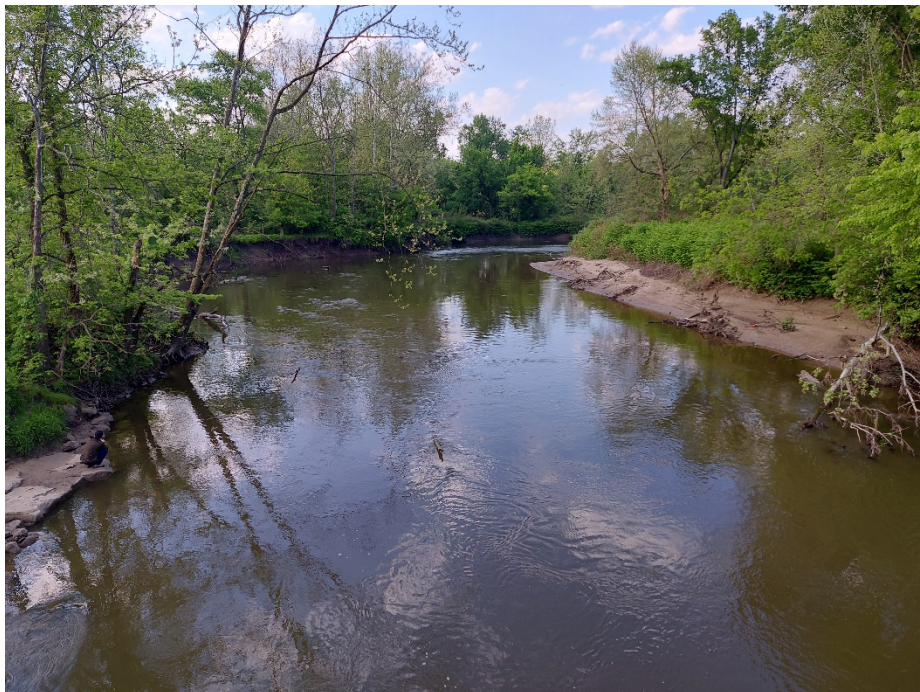
*Photo 4 – Facing south upstream.*

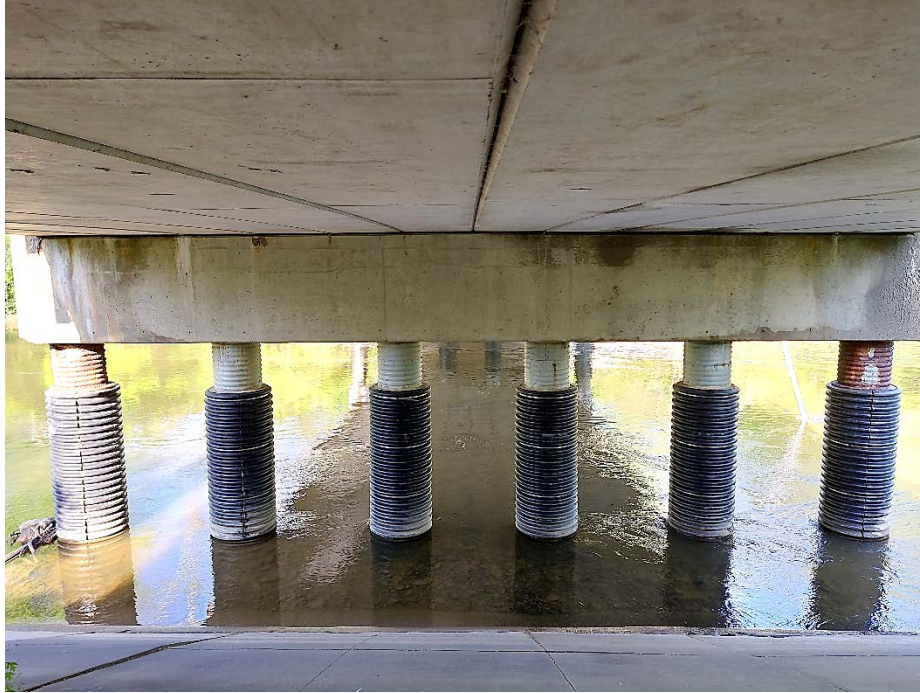
- All piles have been encased in corrugated black plastic pipes held in place with four hose clamps. The annular void has been filled with grout to an approximate elevation of 2.4 feet below the column caps. Above this plastic pipe, galvanized corrugated metal is visible (see *Photo 5*).
- The concrete slope protection at this abutment has some cracks up to 1/8", 1" deep scaling along the waterline, and some vegetation growing in the joints (see *Photo 7*). A portion of the slope protection near the left fascia (downstream side) was repaired in the fall of 2019 by Summit County Engineer Maintenance forces. The repaired portion was observed to be in good condition.
- There is a line of submerged rocks creating turbulence in the flow upstream of Bent 1 (see *Photo 8*).
- There is a missing hose clamp at the top of the Pile 1 encasement on Bent 1 (see *Photo 9*).

*Photo 5 – Facing east – Bent 1 west elevation.*

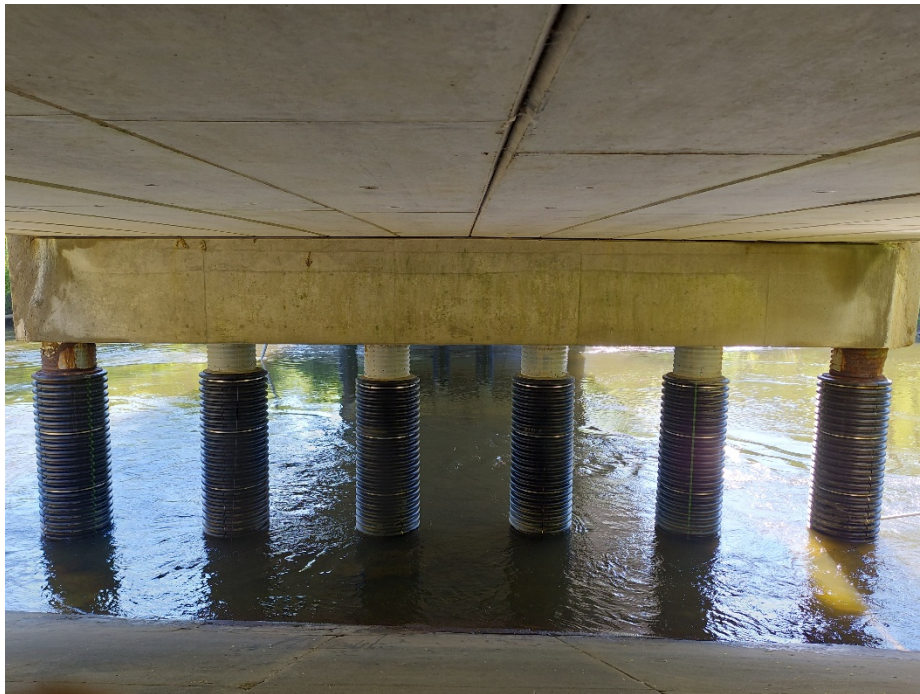
- All piles have been encased in corrugated black plastic pipes held in place with four hose clamps. The annular void has been filled with grout to an approximate elevation of 2.4 feet below the column caps. Above this plastic pipe galvanized corrugated metal is visible (see *Photo 6*).
- There are three 2" diameter holes in the corrugated plastic pipe encasement on the upstream (right) face of Pile 6 (see *Photo 10*).
- There are two missing hose clamps at Pile 6 (see *Photo 11*).

*Photo 6 – Facing west - Bent 2 east elevation.*

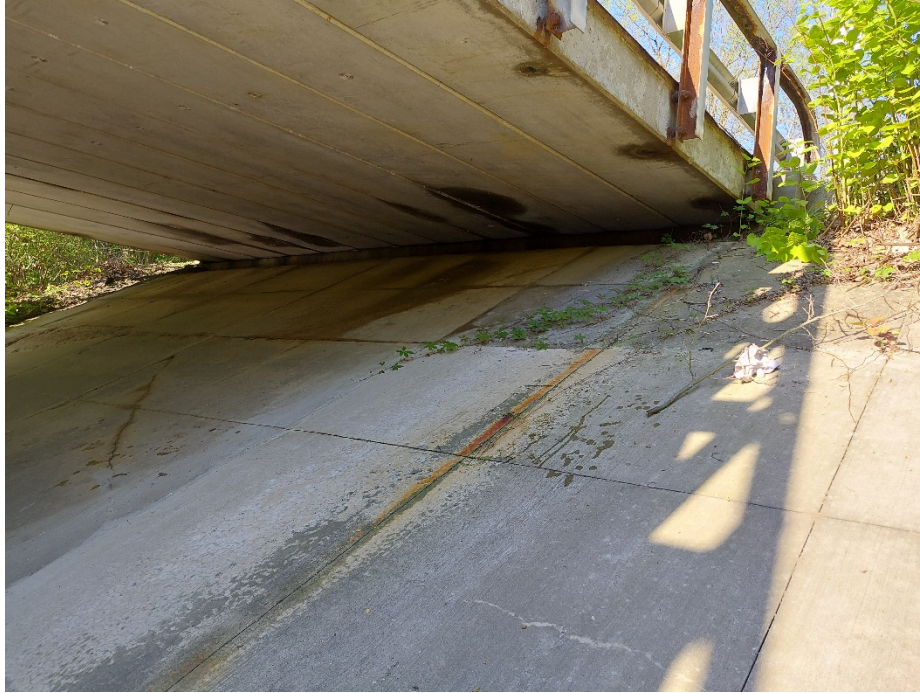
*Photo 7 – Cracking and scaling of Rear Abutment (west) slope protection.*

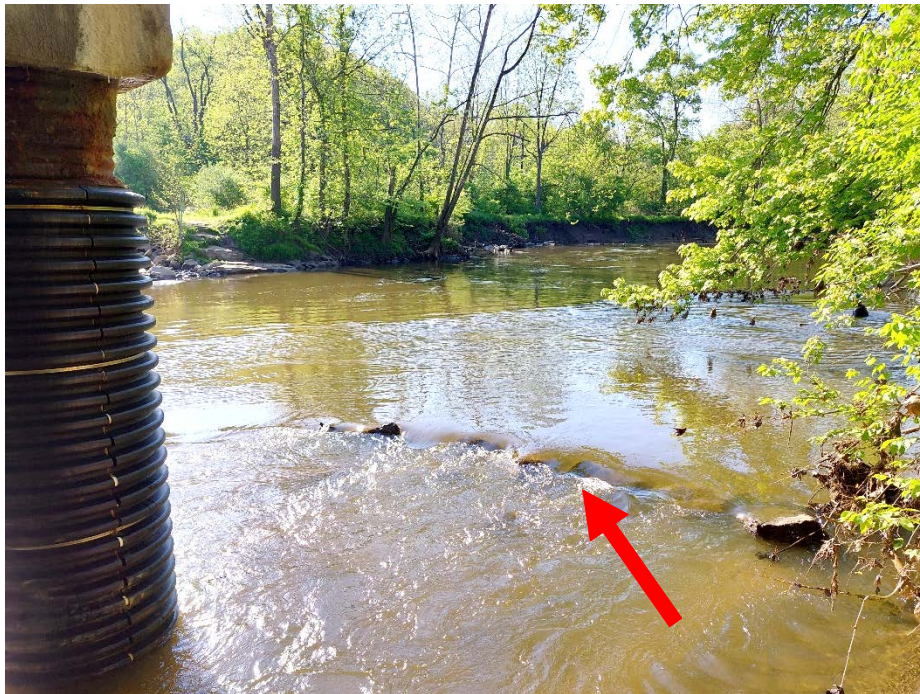
*Photo 8 – Submerged rocks creating flow turbulence upstream of Bent 1.*

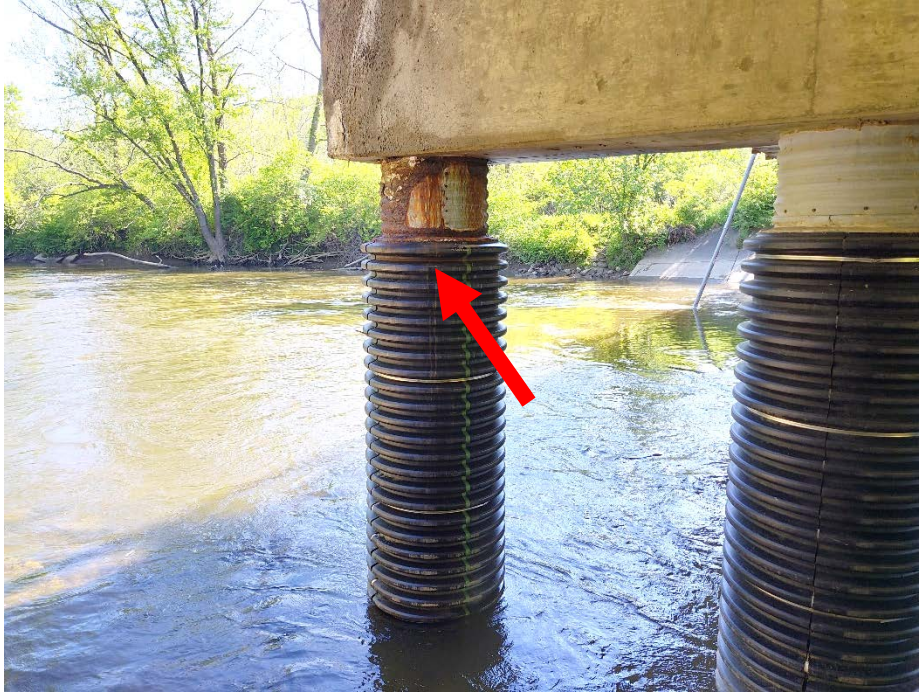
*Photo 9 – Bent 1, Pile 1 – Missing hose clamp at top of plastic pipe encasement.*

- Replace or repair the damaged and undermined concrete slabs on the Forward Abutment slope protection.
- Replace missing hose clamps at plastic pipe pile encasements.
- It is recommended that a routine underwater bridge inspection of the substructure elements be performed at a maximum interval of 60 months. Underwater inspections should also take place following any significant or potentially damaging event.

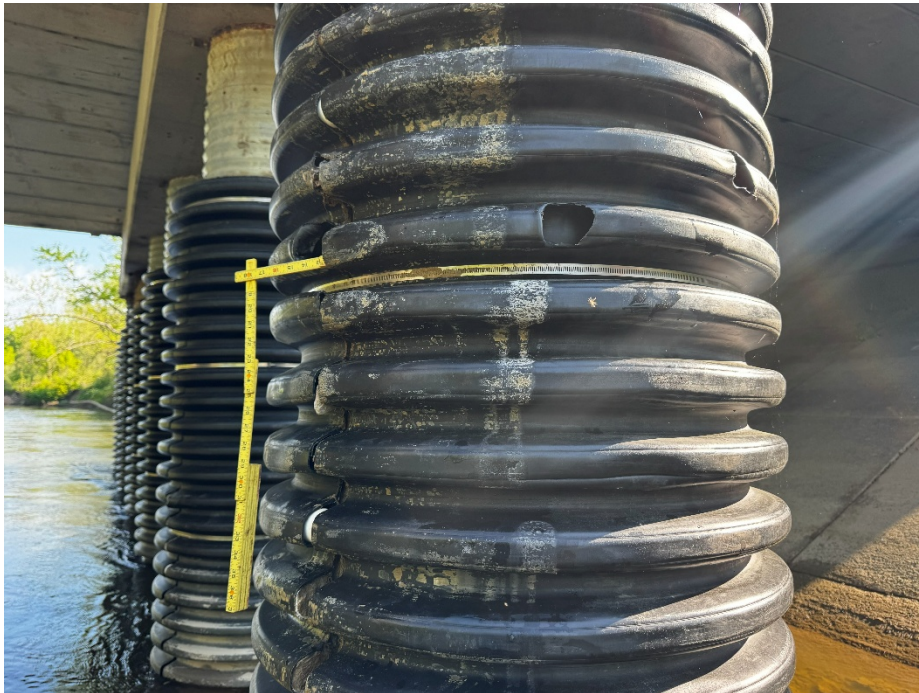
*Photo 10 – Bent 2, Pile 6 – (3) 2" diameter holes in plastic pipe on upstream face of pile.*

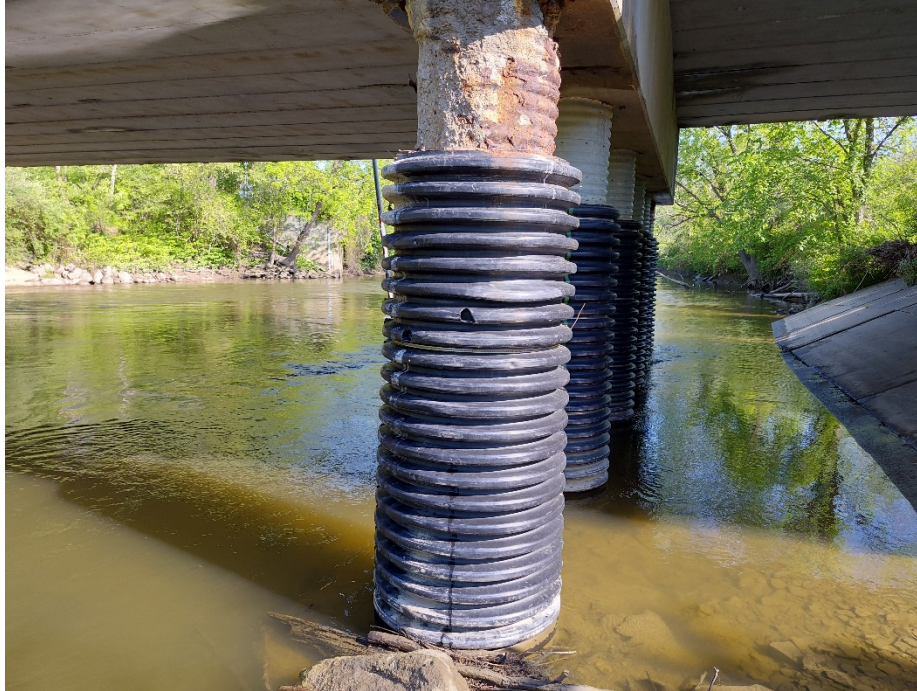
*Photo 11 – Facing North - Bent 2, Pile 6. Missing top and bottom hose clamps on plastic pipe encasement.*

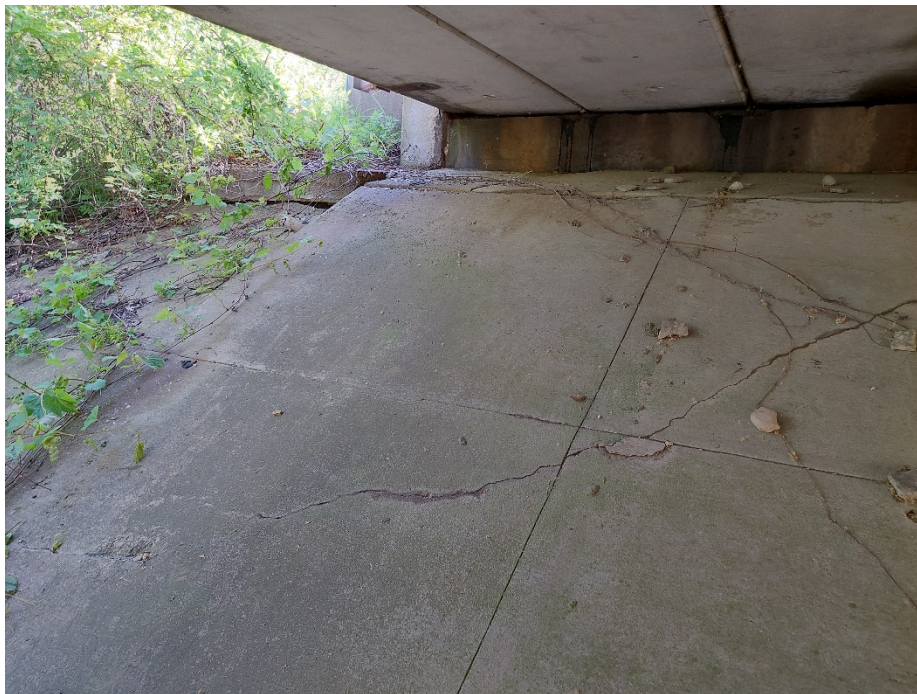
- There is one missing hose clamp at Pile 1.
- The concrete slope protection at this abutment has numerous cracks up to 1/8", 1" deep scaling along the waterline, and some vegetation growing in the joints (see *Photo 12*).
- A 12' x 8' triangular area in the northeast corner bounded by a 1/8" crack, is hollow sounding when struck with a hammer (see *Photos 12 & 13 and Sounding Sheet* for location). Probing at the joint detected a 17-inch tall void under this section, due to undermining of the slab. The undermining has increased since the 2021 inspection (10" of undermining was measured in 2021).
- In the southeast corner of the slope protection under the bridge, there is an approximately 10' x 10' area that is hollow sounding when struck with a hammer, but no concrete deterioration was noted. (see *Sounding Sheet* for location).

*Photo 12 – Forward Abutment (east) slope protection – typical cracking.*

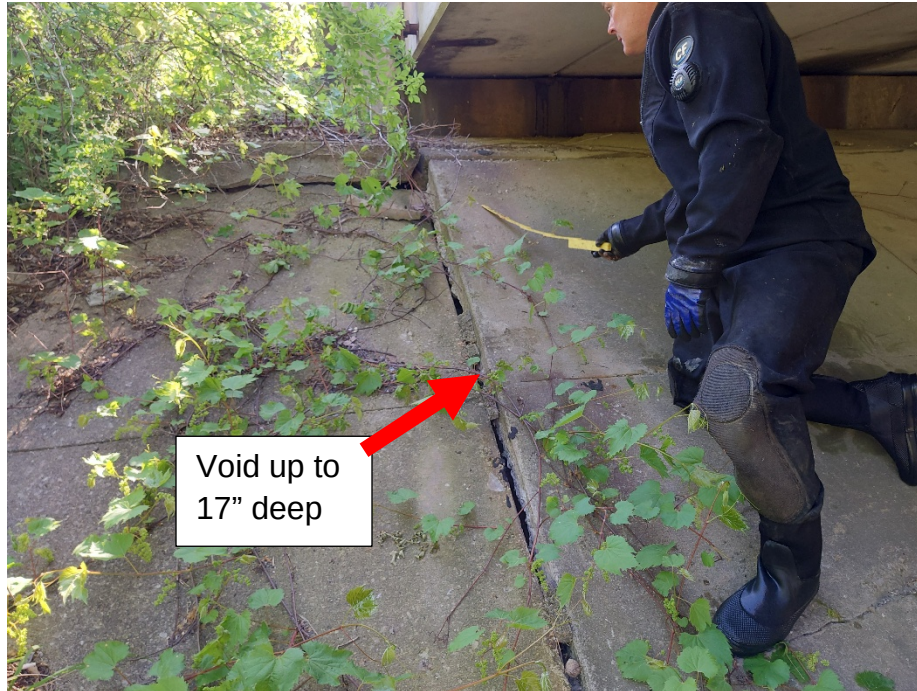
On the east bank, material loss from under the slope protection continues. The depth of undermining of the cracked, triangular-shaped northeast corner has increased by 7" in depth since the 2021 inspection. The undermined area in the southeast corner remains unchanged from the 2021 inspection.

*Photo 13 – Facing East – Void, cracking, and settlement of Forward Abutment slope protection (northeast corner).*

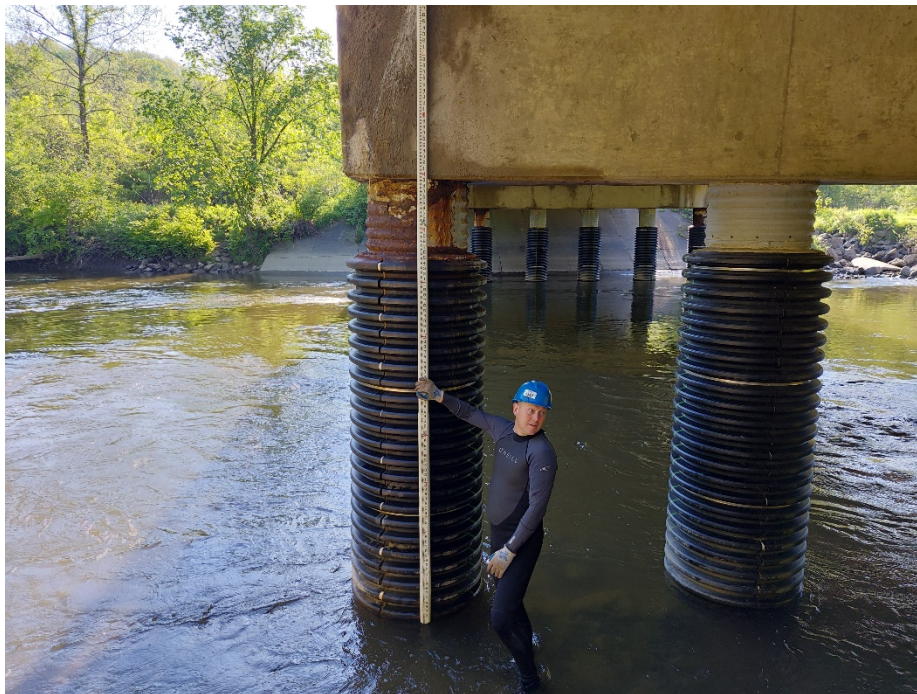
Soundings were taken throughout the structure at 10, 20, 30, 100 and 200 feet upstream and downstream using a surveyor's sounding rod. The hydrographic reference point is located at the bottom of the Bent 1 cap at Pile 1, which is the left (north) pile (see *Photo 14*). The water surface was measured to be 8.9 feet below the reference point during this inspection. The measurement taken during the 2021 underwater inspection was 9.5 feet.

*Photo 14 – Clearance level measurement - Bottom of Bent 1 cap at Pile 1.*
