STATE OF OHIO  
**BRIDGE INSPECTION REPORT**  
**SUM-C0111-0000 \_(7751001)**

County: 77 - Summit  
69428 - SAGAMORE HILLS TWP (SUM county)  
HIGHLAND RD  
over CUYAHOGA RIVER  
1 - Highway  
5 - Prestressed concrete  
05 - Box Beam or Girders - Multiple

**Inspection Date:** 06/04/2026  
**Inspection Type:** Routine (SNBI)

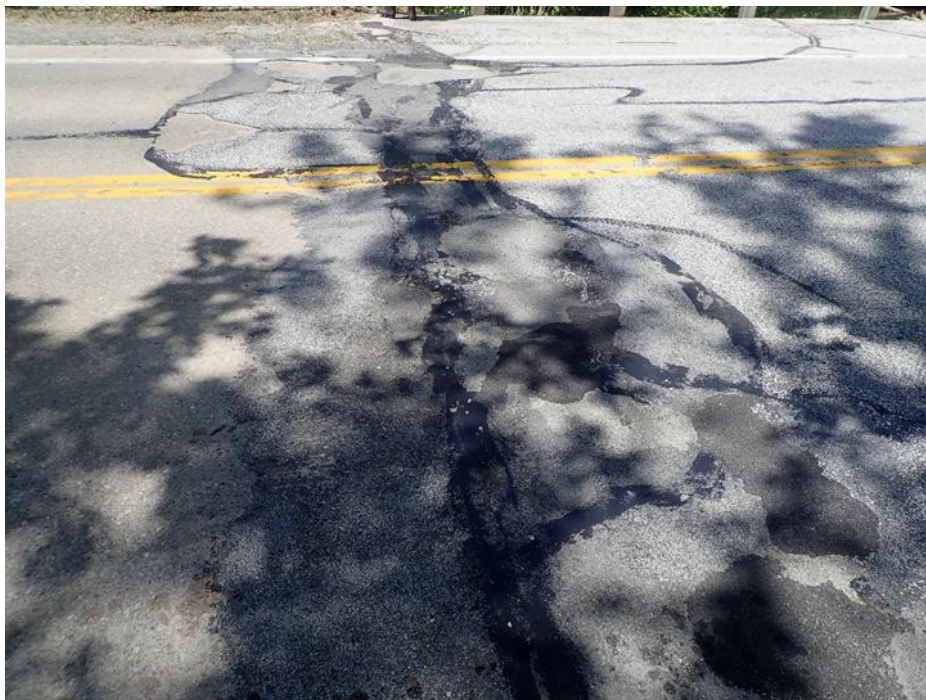
PHOTO 2

Crack throughout. Asphalt patches at bridge ends and at intermediate expansion joints. Joint at rear abutment has several potholes and moderate patching. Four transverse cracks the width of the bridge

Description Rear joint

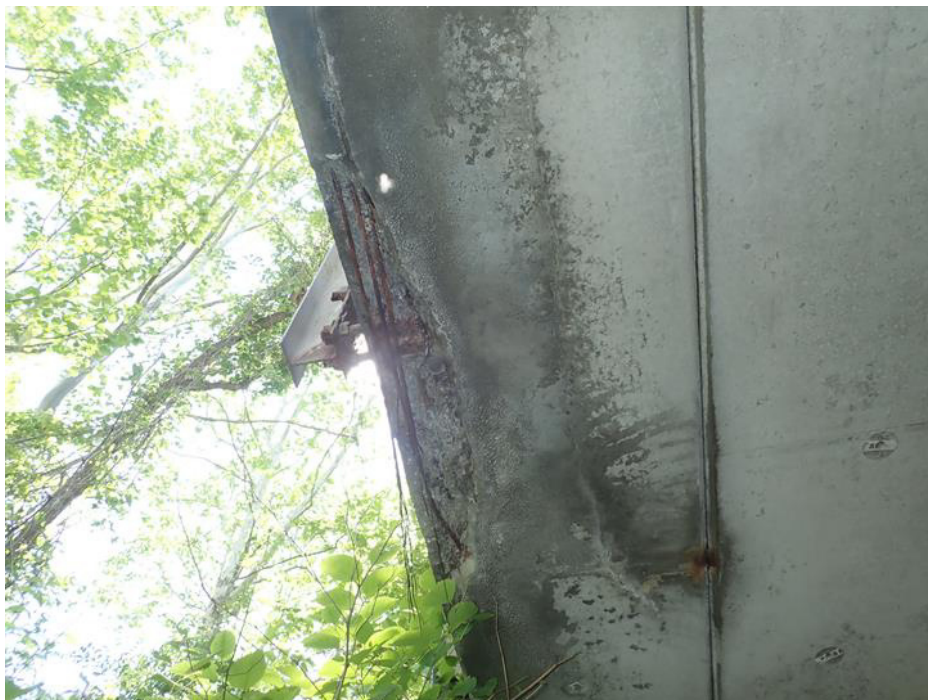
PHOTO 6

Beam 12 is wet/saturated and has a near full length longitudinal crack indicating a delamination (~9" to 12" from exterior face). Beam 12 has spall with 3 broken strands near midspan. Near pier 1 approximately 10' of cracking and spalling in top of beam.

Description Beam 12, span 1 - 3 broken strands

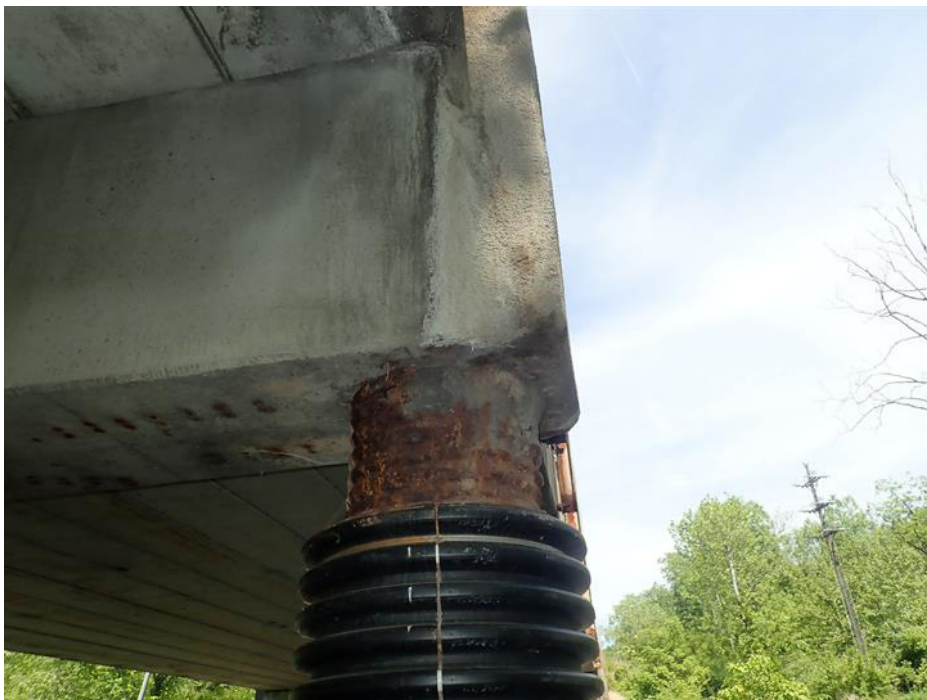
PHOTO 8

Major corrosion of top 2 feet of piles 1 and 6 (both piers) and pile 2 at pier 2. Pier 2, column 6 3 ft x 3 ft spall, 4 inches deep and a 1'x2'x4" deep.

Description Pier 1 pile 6 deterioration

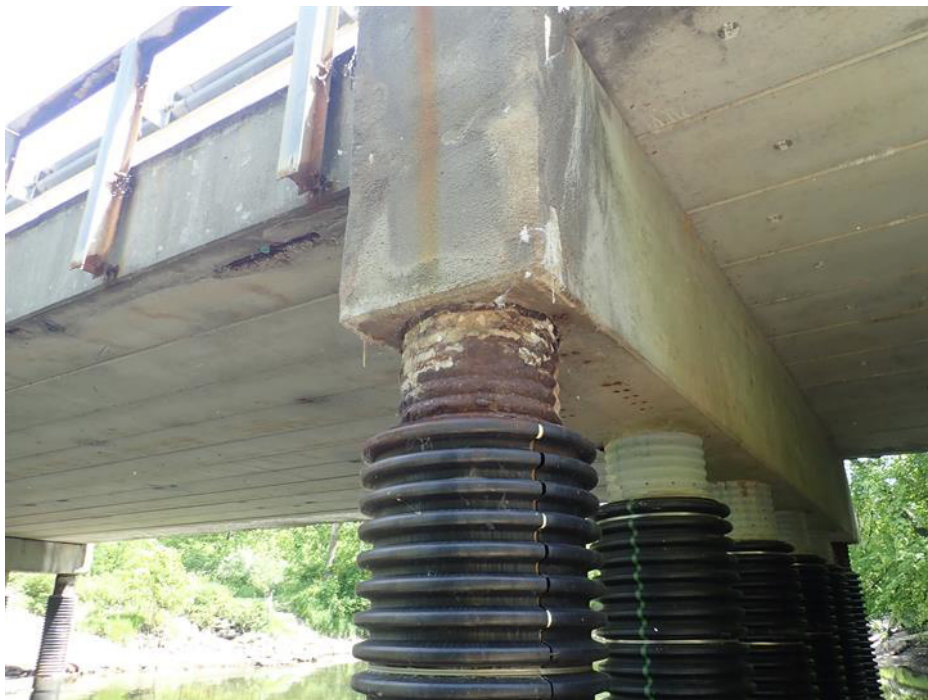
PHOTO 9

Description Pier 1 pile 1 deterioration

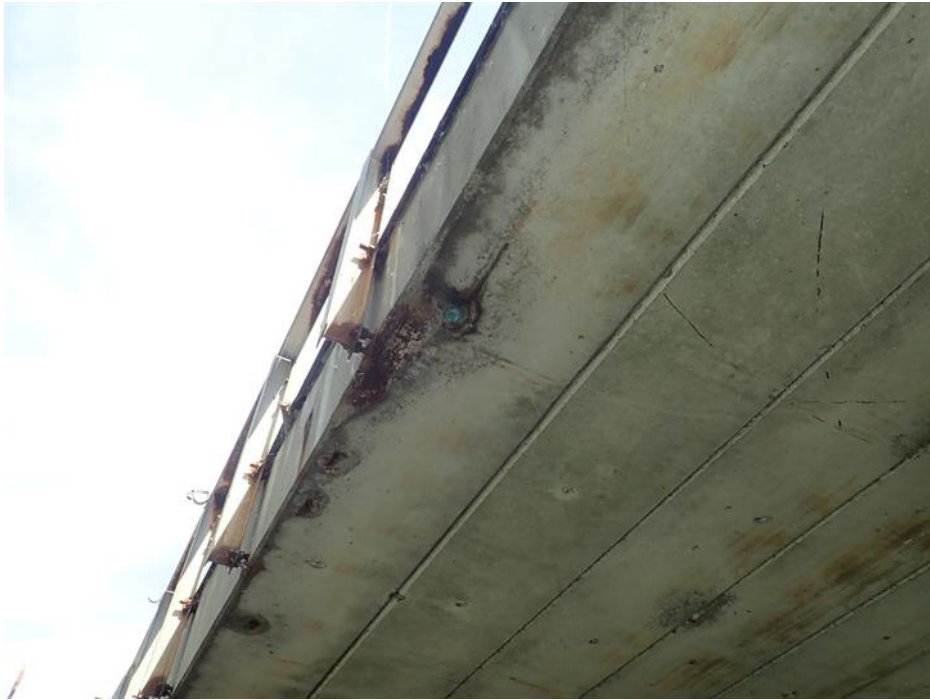
PHOTO 13

Beam 1 - Multiple 1-3 SF spalls around beam drain holes and bridge railing anchorage with up to 3 exposed strands. Delamination ~1.5 ft wide) near west end of span.

Description Beam 1, span 2 exposed strands

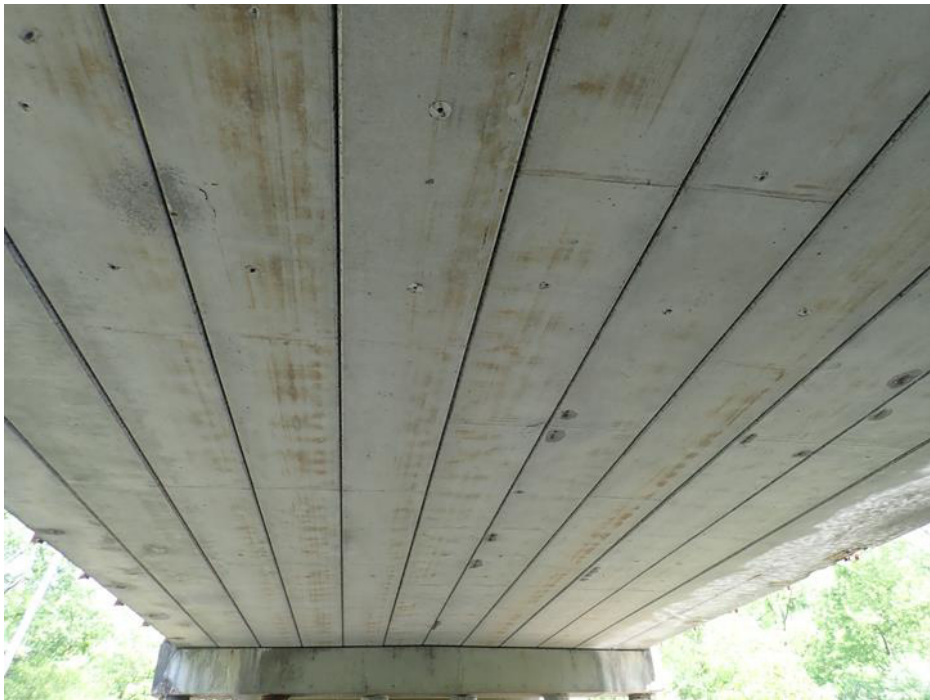
PHOTO 14

Beam 7 - Seven 1 SF spalls near north edge of beam with 1 exposed strand.

Description Beam 7 span 2 exposed strand

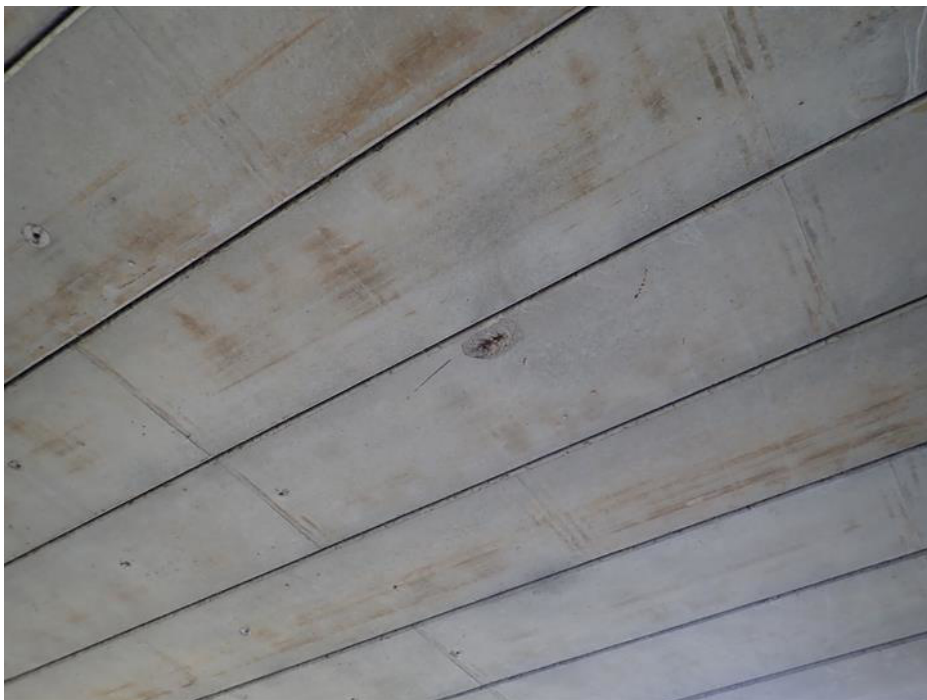
PHOTO 15

Beam 9 - Three 1 SF and one 3'x1' spalls near north edge of beam with 1 exposed strand. Two 1 SF spalls near south edge of beam with 1 exposed strand.

Description Beam 9 span 2 exposed strand

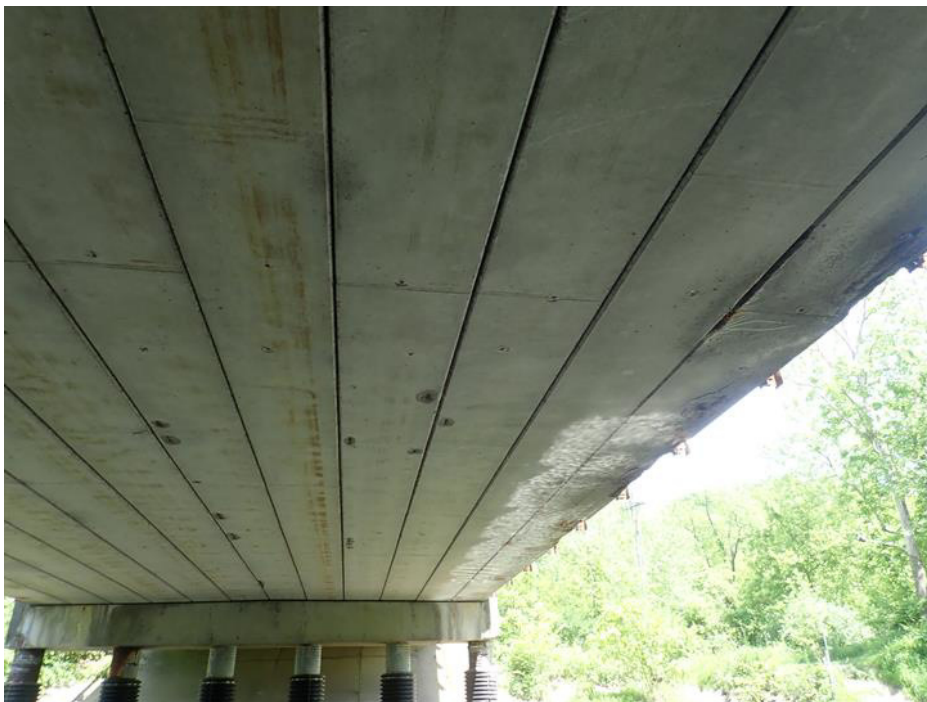
PHOTO 16

Beam 12 - Four spalls along south edge with up to 4 exposed strands (3 broken). Longitudinal cracking along fascia with seven shallow and one 2.5 ft x1ft x 0.5 ft deep spall at top.

Description Beam 12 span 2 exposed strands

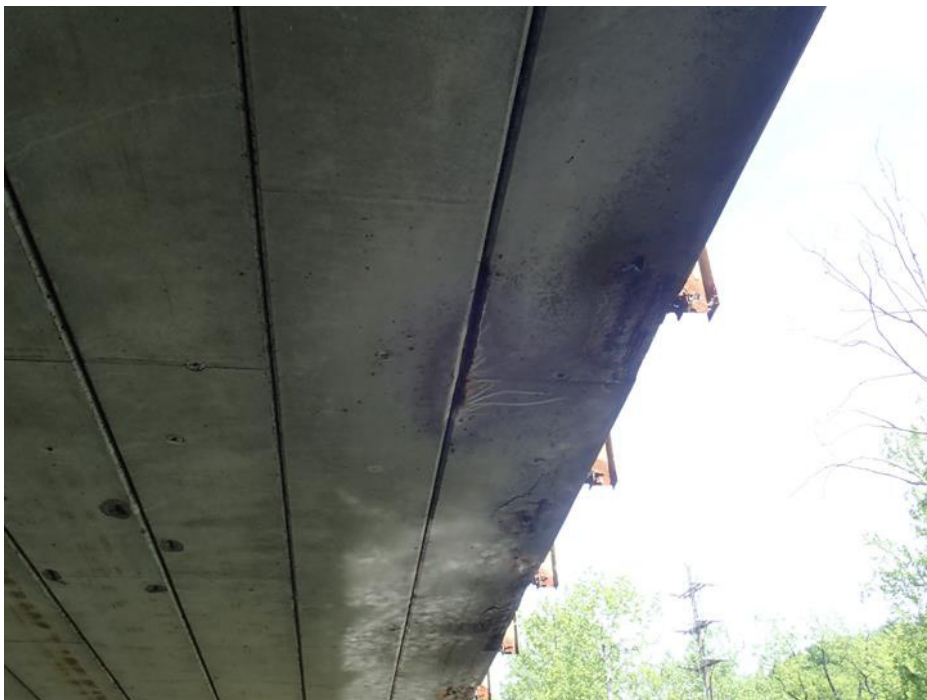
PHOTO 17

Description Beam 12 span 2 exposed strands

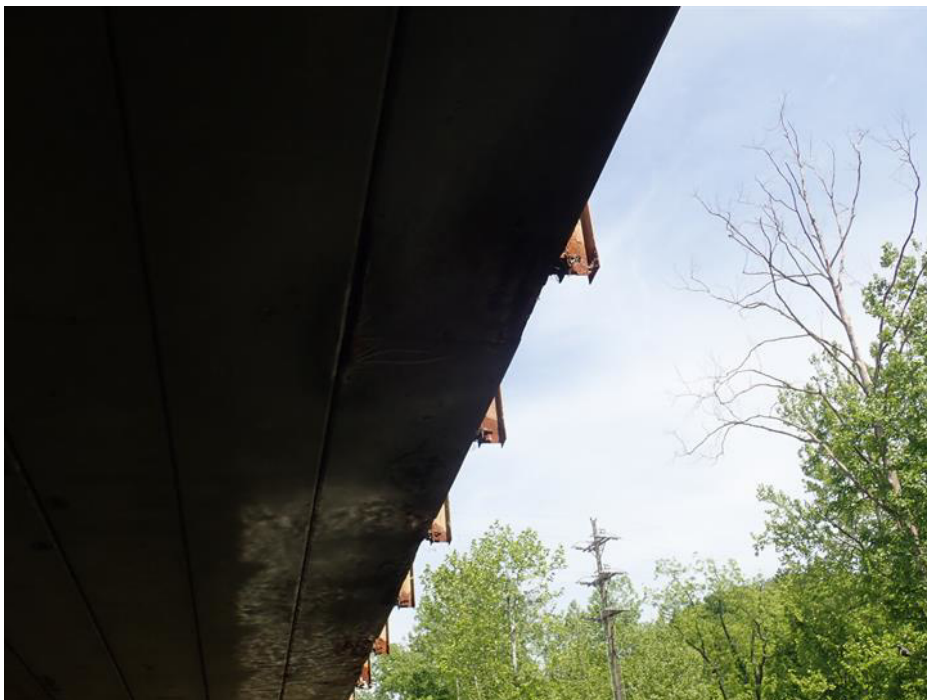
PHOTO 18

Description Beam 12 span 2 exposed strands

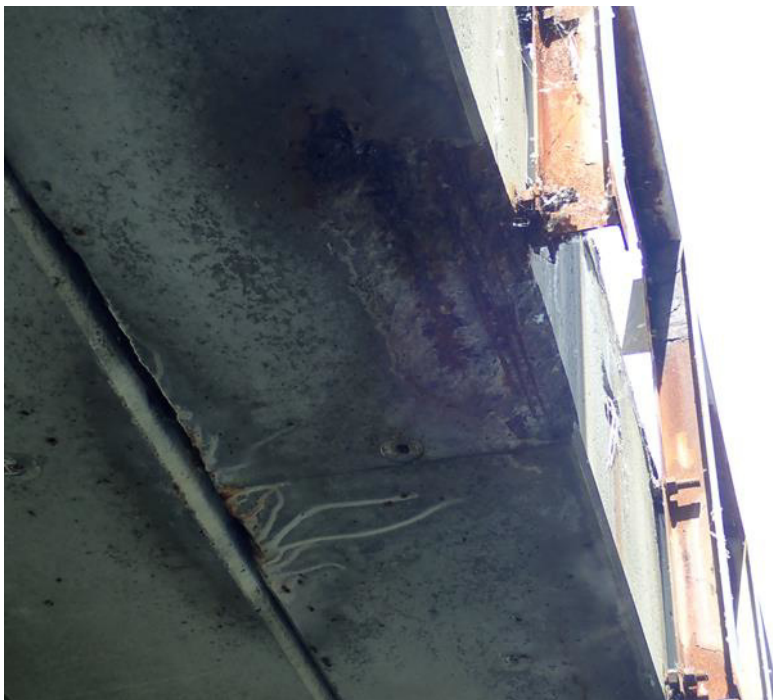
PHOTO 19

Major perforations at guardrail post webs. Six posts at right and nine posts at left affected. Several others heavily rusted. Several bolts from handrail to posts missing.

Description Beam 12 span 2 exposed strands and rusted guardrail post

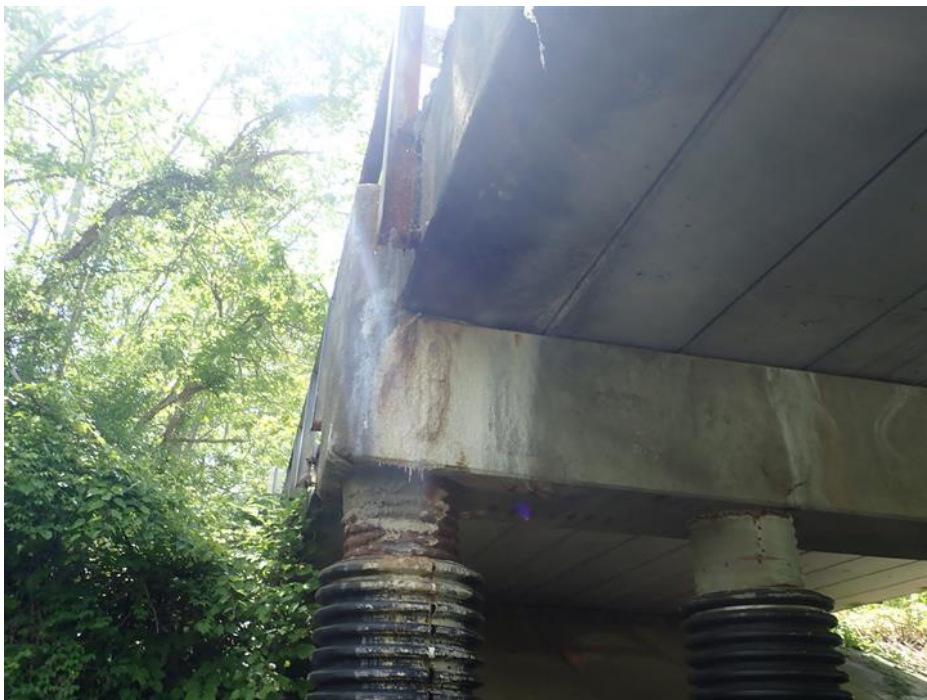
PHOTO 20

Description Pier 1 pile 6 deterioration

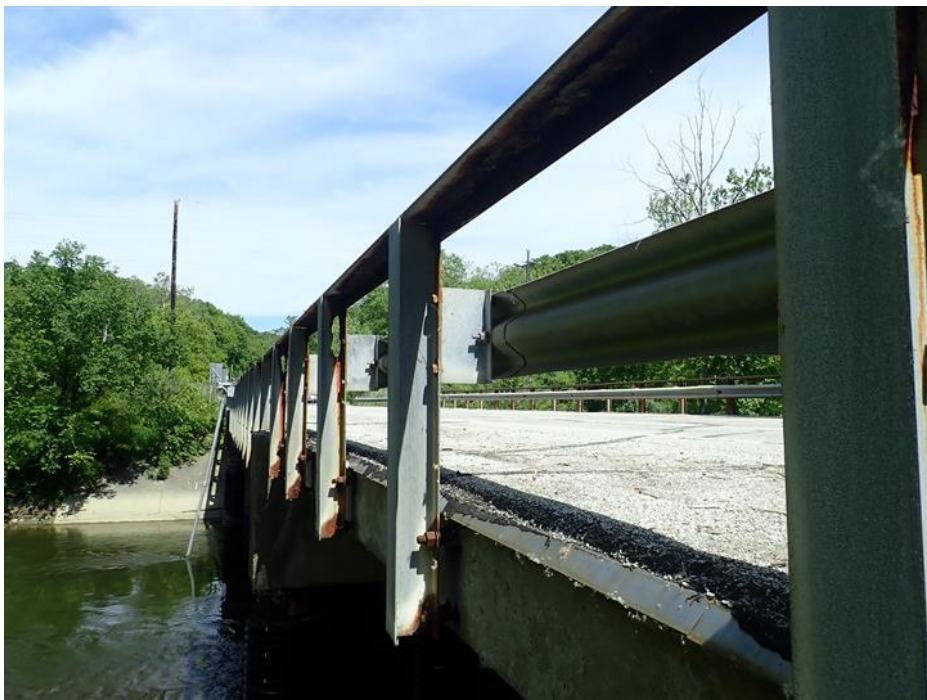
PHOTO 24

Description Rusted/perforated guardrail posts

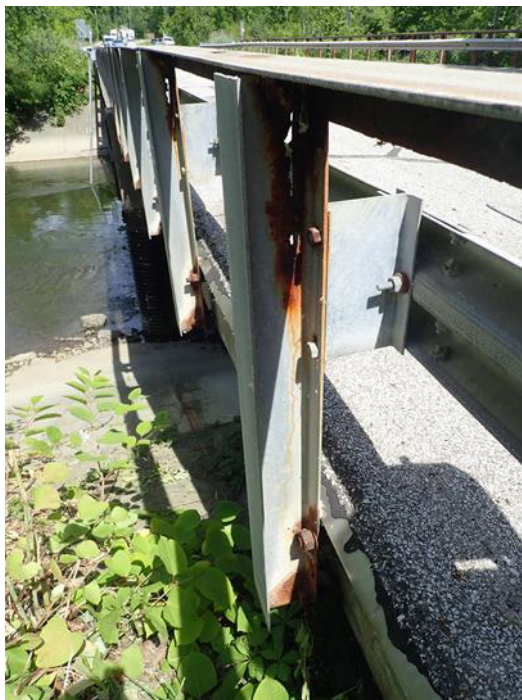
PHOTO 25

Description Rusted/perforated guardrail posts

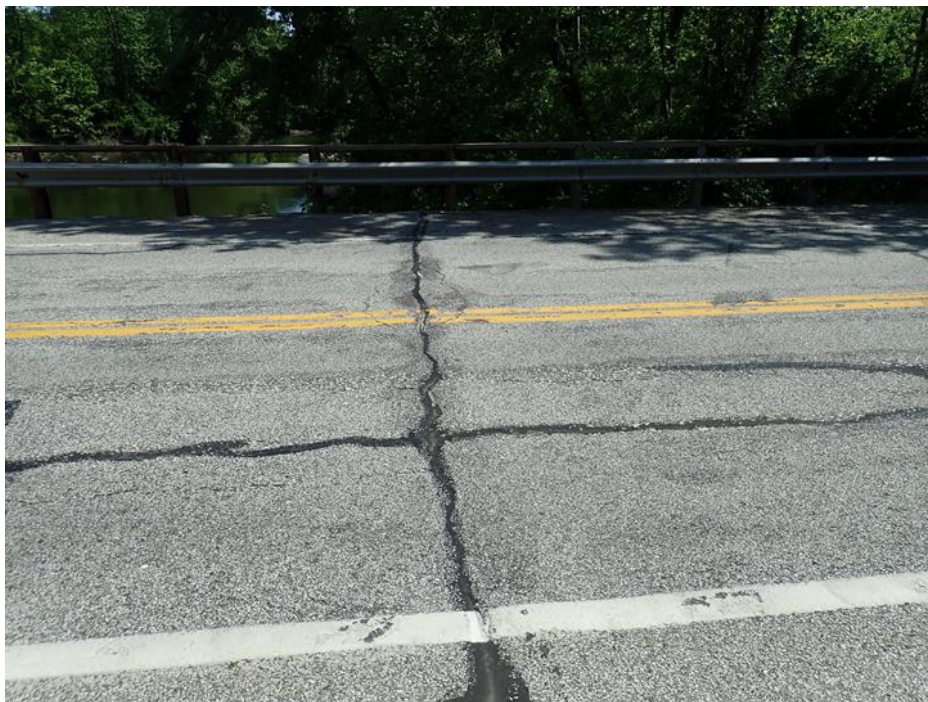
PHOTO 26

Description Cracking in deck

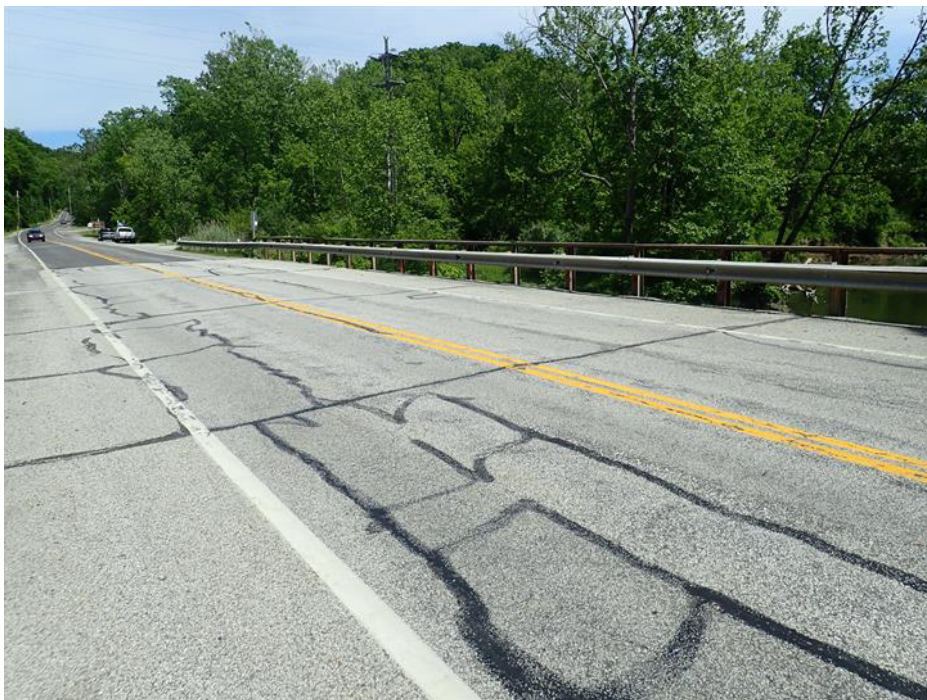
PHOTO 27

Description Cracking in deck

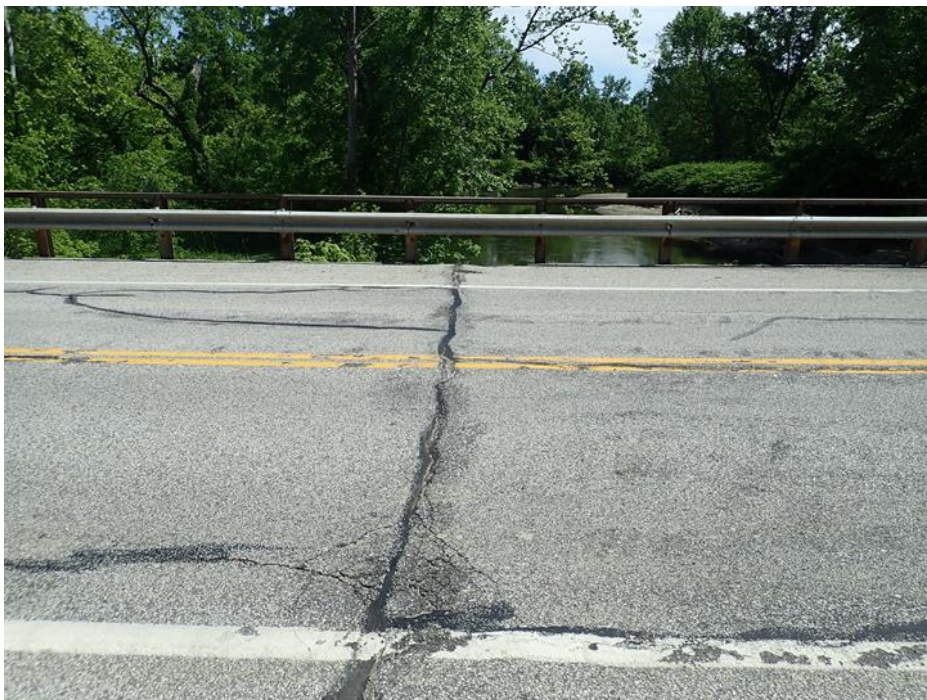
PHOTO 28

Description Cracking in deck

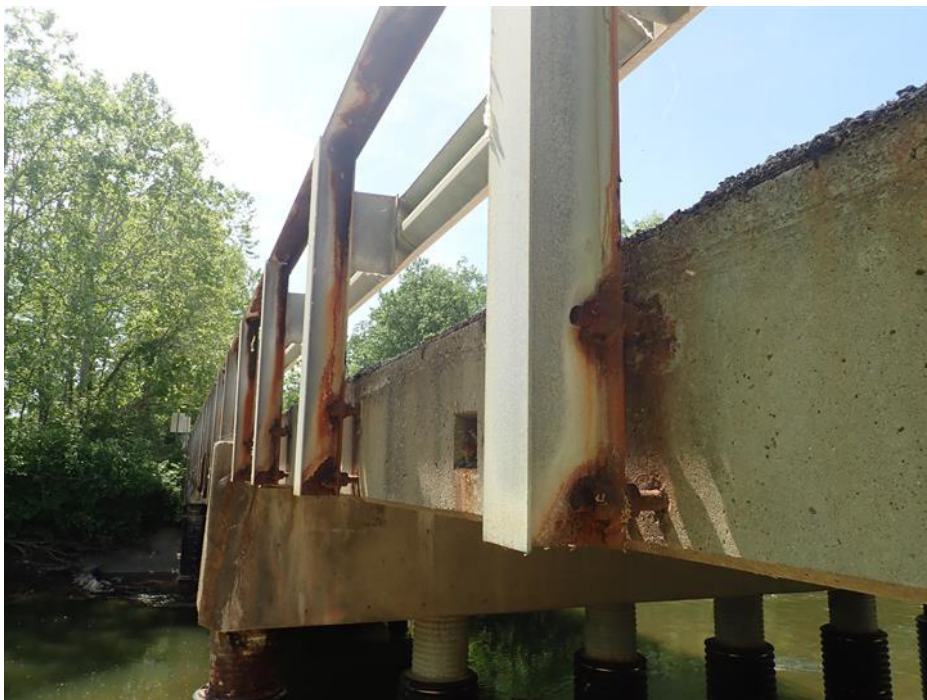
PHOTO 31

Description Guardrail deterioration

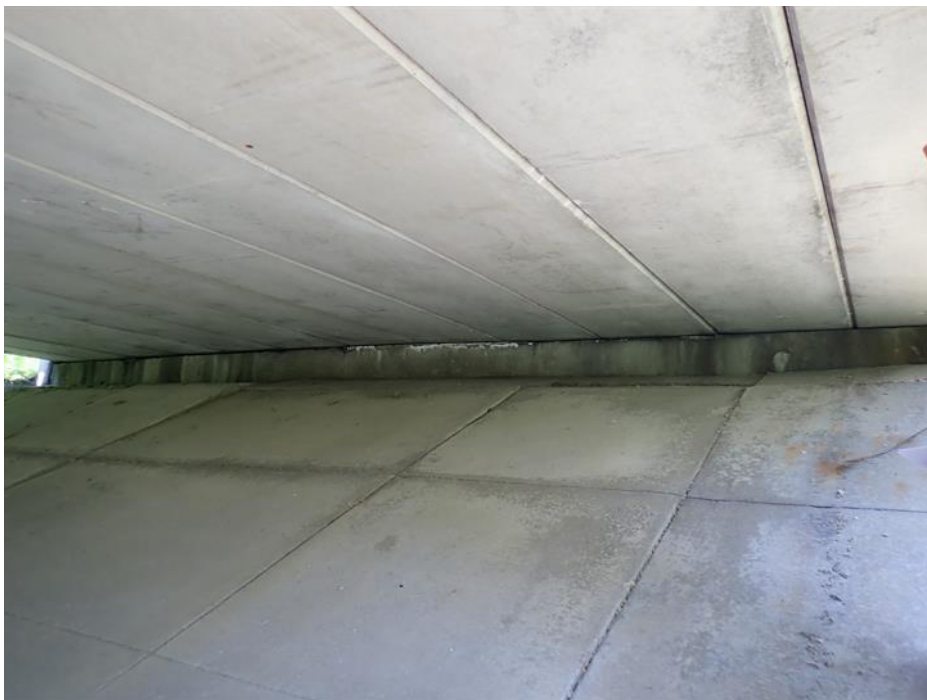
PHOTO 33

At forward abutment crack with efflorescence and leaking from beam seat.

Description Forward abutment

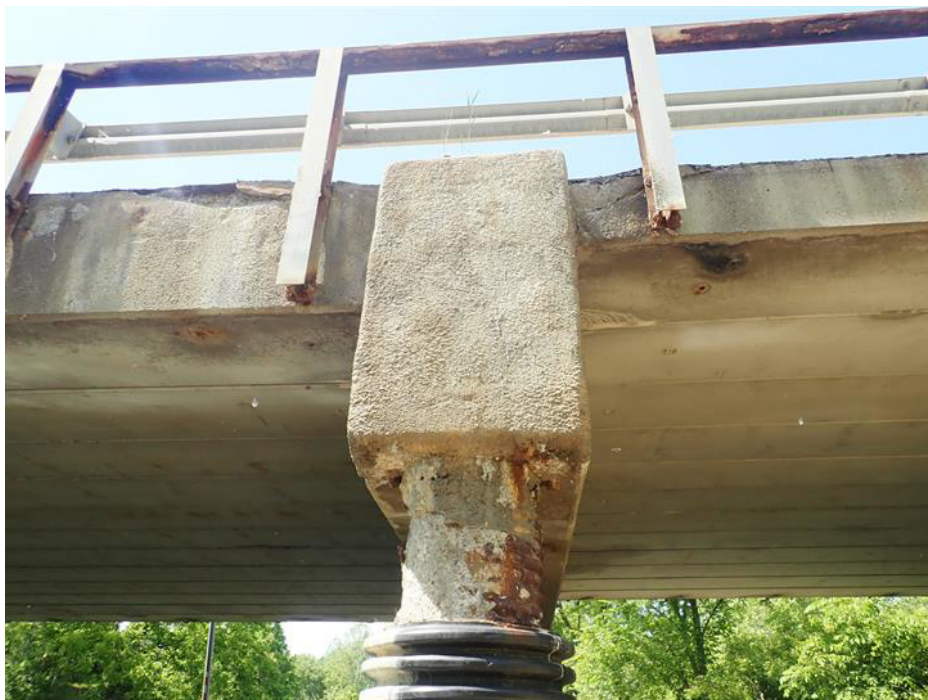
PHOTO 36

Description Pier 2 pile 6 spall

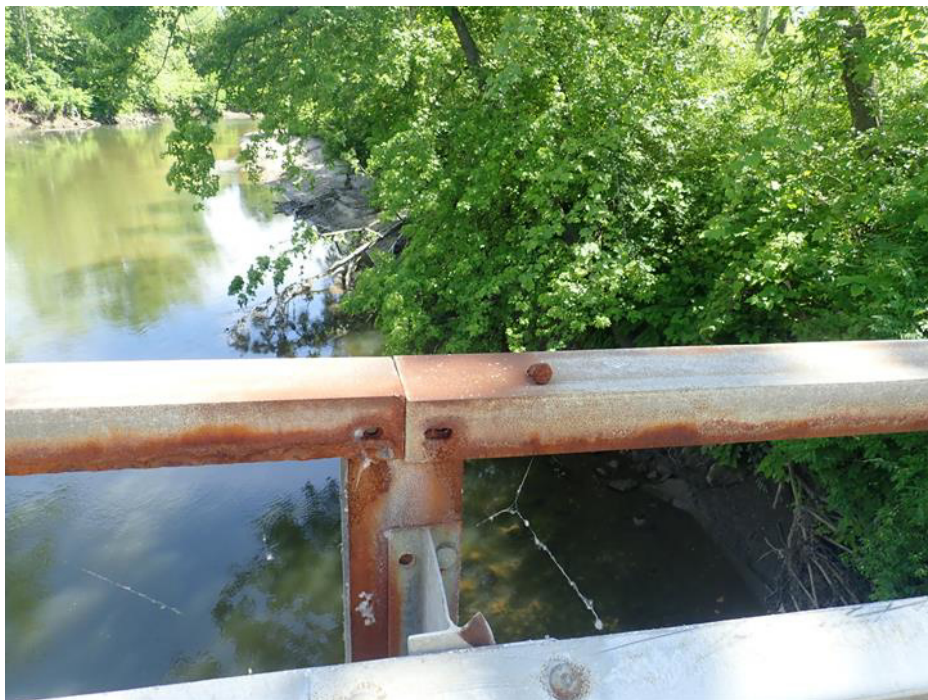
PHOTO 37

Description Missing bolt in guardrail

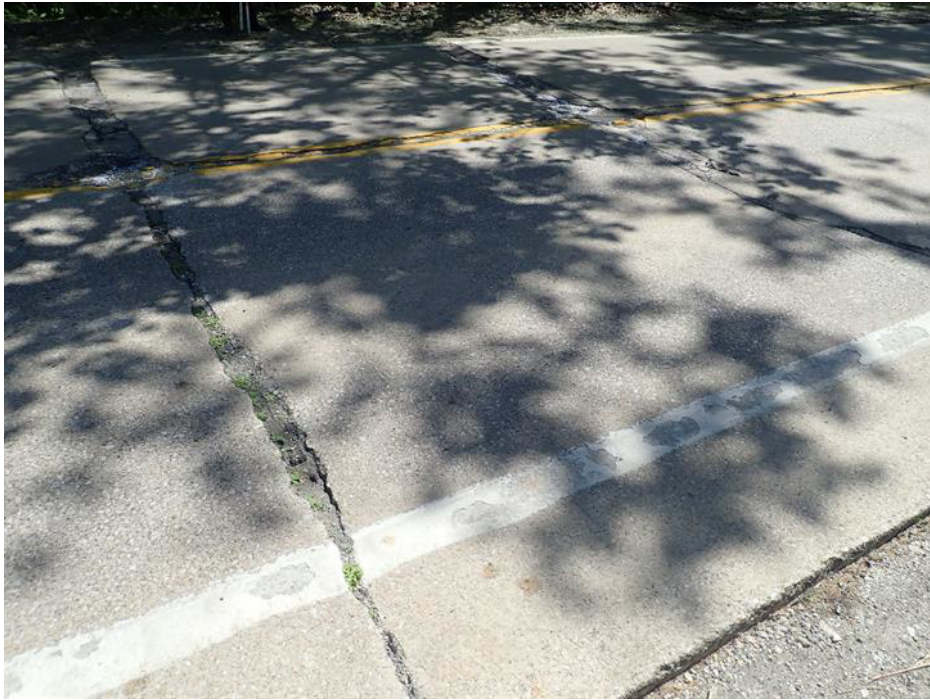
PHOTO 39

Rear slab has a longitudinal crack. Minimal if any change from last report.

Description      Cracks in rear approach
