STRUCTURAL EVALUATION REPORT FOR LOWER DECK BIKE PATH CUYAHOGA COUNTY, OHIO

THE DETROIT-SUPERIOR BRIDGE BR#: CUY-6-1456 SFN: 1800930

Report Submitted: April 4, 2014

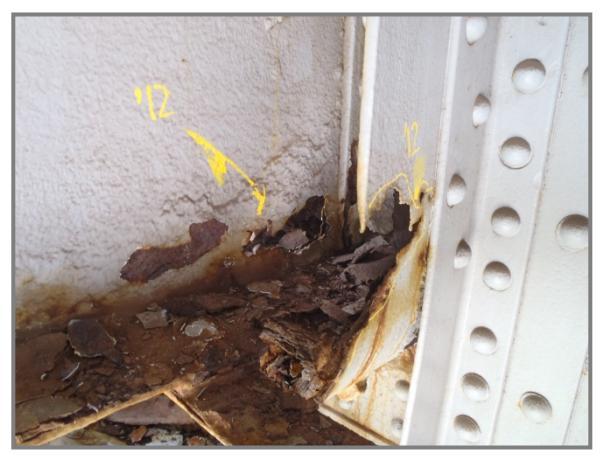
The Detroit-Superior Bridge is in Poor Condition [4-NBIS] overall, due to deterioration noted throughout the structure. The Main Truss Span lower chord members and gusset plates exhibit advanced section loss. This loss is typically concentrated to the areas below the upper level deck, occurring at the last five panel points at each end of the span. In addition, isolated framing elements exhibit advanced section loss due to water infiltration at locations were the trusses or eyebar hangers pass through the deck, and at stringer saddle bearings (see Photo 2). Framing elements at the west and east ends of the Main Truss Span also exhibit heavy section loss due to water infiltration at the joints.

Photo 2 – Typical lower deck stringer with 100% section loss in web and bottom flange at saddle bearing.

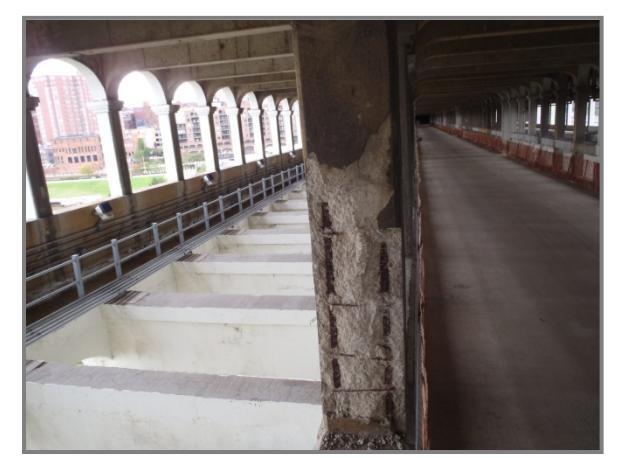
Photo 3 – Typical spall with exposed reinforcement in concrete column.

The reinforced concrete approach spans exhibit numerous deficiencies throughout. Concrete floorbeams, columns, and jack arches commonly exhibit minor to moderate spalls with exposed reinforcing (see Photo 3). The concrete arch ribs commonly exhibit areas of spalled or delaminated concrete, as well as longitudinal and map cracking.

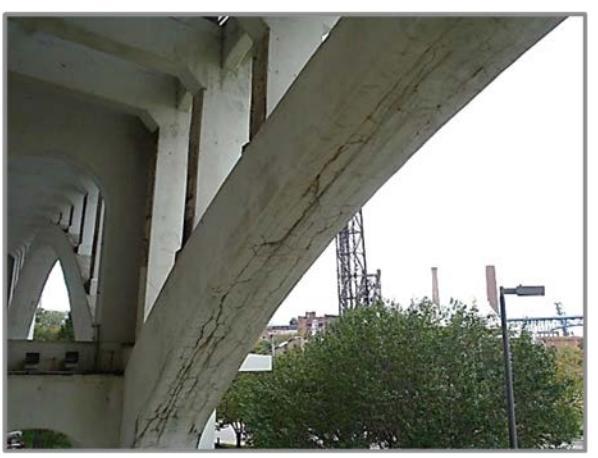
The reinforced concrete arch ribs were generally in fair condition due to spalled or delaminated concrete with isolated map and longitudinal cracking (see Photo 6). Although deterioration is present in isolated locations, the reinforcing steel typically has negligible section loss. In addition, the spalled locations are minor relative to the size of the sections and do not occur at a controlling location on the arch ribs. As a result, the as-inspected rating factors are equal to the as-built rating factors.

Photo 6 – Map cracking throughout underside of Arch A in Span 10, looking west toward Pier 9.

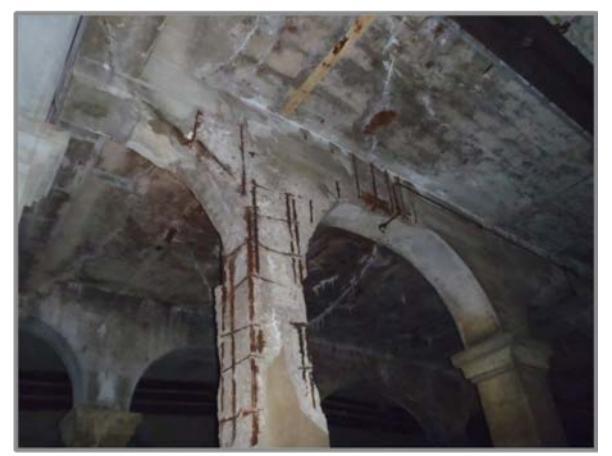
Photo 7 - Easternmost column in West Side Station jack arch Line C with heavy spalling and exposed rebar on all faces

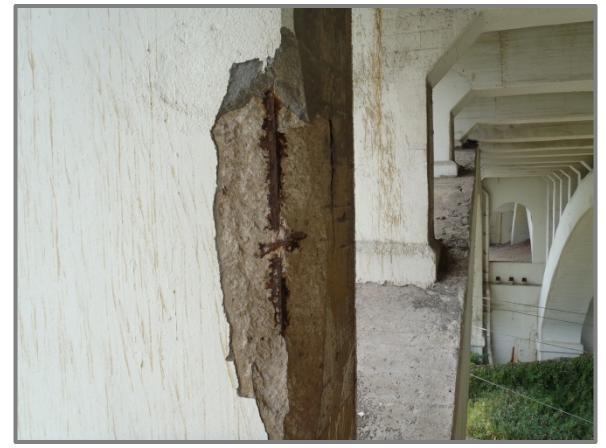
Photo 8 - Northeast face of Span 2, arch line D, Column 13 with 5' high by 1' wide spall with exposed reinforcing

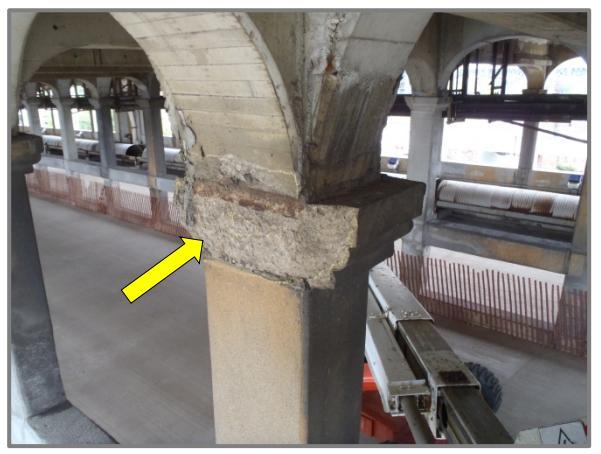
Photo 9 – Span 7, jack arch line B, Column 7 with west face of decorative capital fully spalled.

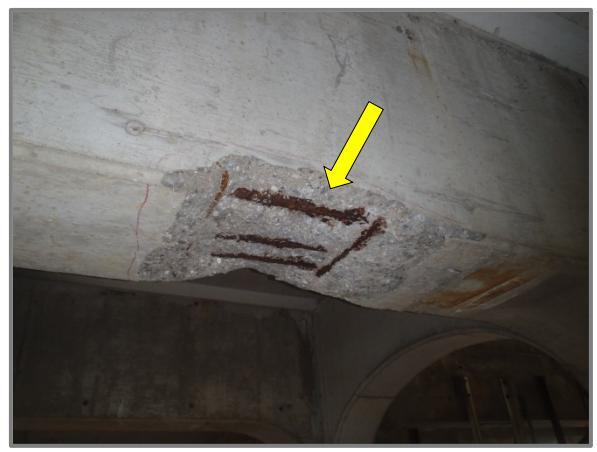
Photo 10 – West face of Floorbeam 9 in Span 3 between Columns B and C with spall and exposed reinforcement in beam underside near midspan.

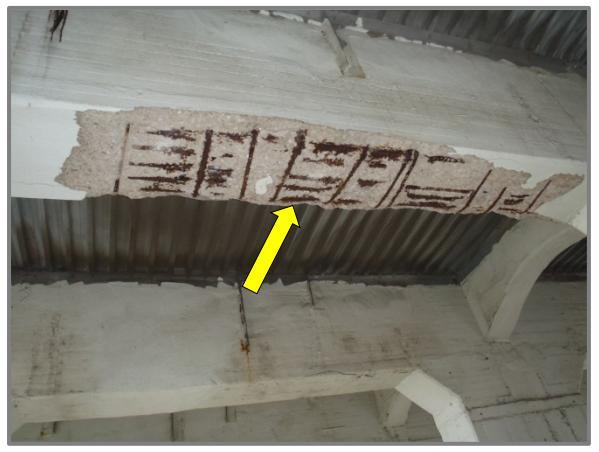
Photo 11 – Span 3 Lower Floorbeam 6 between Arch C and Arch D with large spall to floorbeam underside with exposed reinforcement exhibiting active corrosion.

Similar to the upper deck floorbeams, a number of the lower floorbeams have been replaced during the various rehabilitations of the bridge. Many of the lower concrete floorbeams exhibit moderate spalling with exposed reinforcement and isolated delaminated areas (see Photo 11).

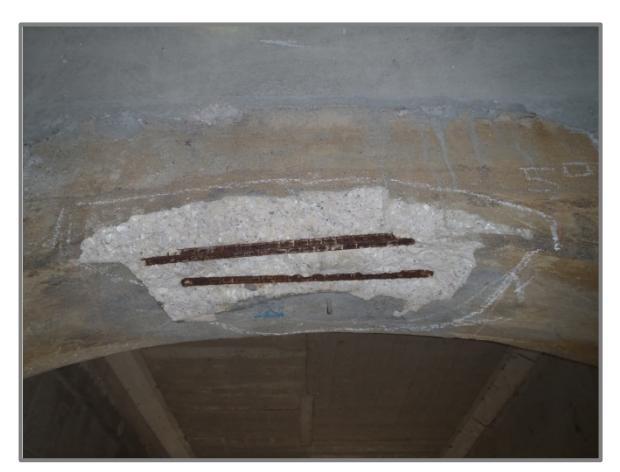
Photo 13 – Jack arch exhibiting an underside spall with exposed reinforcement in Span 1 Column Line B. Note that no section loss has occurred on exposed rebar.

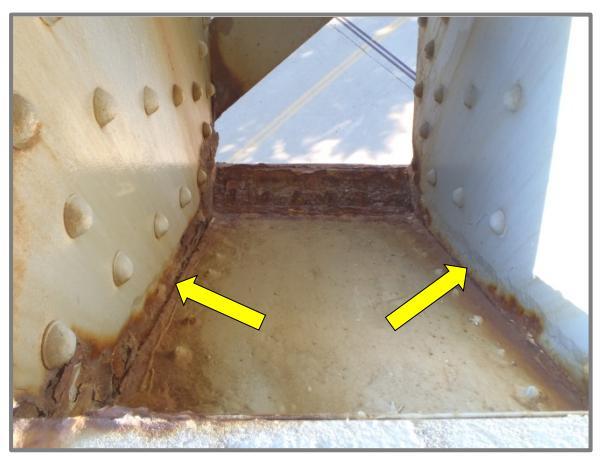
In the as-inspected condition, 17 out of 194 truss members exhibited more than 5% section loss, three locations exhibited between 10% and 20% section loss, and one vertical member (L3-U3 South) exhibited over 20% section loss. Significant deterioration was noted primarily in lower chord and web members below the upper deck level, as well as gusset plates. The controlling lower chord losses typically occur on the interior faces web plates along internal diaphragms or gusset plate edges (see Photo 15). Many of the internal diaphragms and stay plates at these locations exhibit isolated areas of 100% section loss. Upper chord members and lower chord members above the main deck typically exhibit minimal or no section loss (see Photo 16).

Photo 15 – South Truss L23-L24 with pitting on interior web plates up to 3/8" along the internal diaphragm at L24.

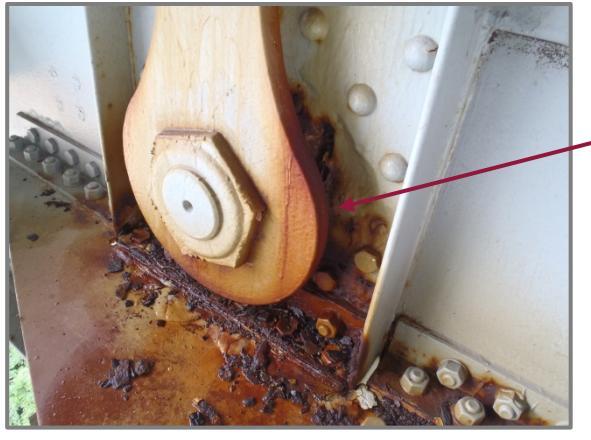
Photo 18 – East lower eyebar connection at L4 North. Note active corrosion in area and up to 3/8" pitting on pin plate.

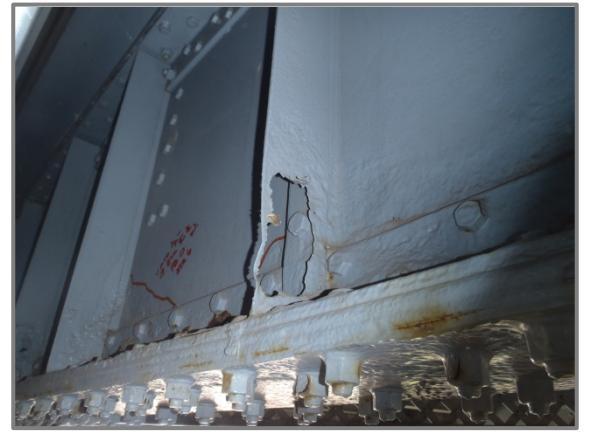
Many of the upper steel floorbeams exhibit heavy section losses, including isolated locations of 100% section loss to the web plates along upper framing lateral bracing connection plates at hanger locations. However, since the floorbeams are typically governed by positive bending at midspan, only the end floorbeams at Panel Points 0 and 24 are governed by as-inspected conditions. These floorbeams exhibit heavy section loss to the webs and 100% section loss to multiple transverse web stiffeners (see Photo 20). In addition, the bottom cover plates and flange angles exhibit isolated pitting which has been cleaned and painted. Despite these levels of deterioration, the as-inspected end floorbeams rate above 1.10 for all load cases, and the remaining floorbeams are controlled by as-built conditions with rating factors also above 1.10.

Photo 20 – West face of Floorbeam 0 with heavy losses to the web plate, web stiffeners and bottom cover plates.

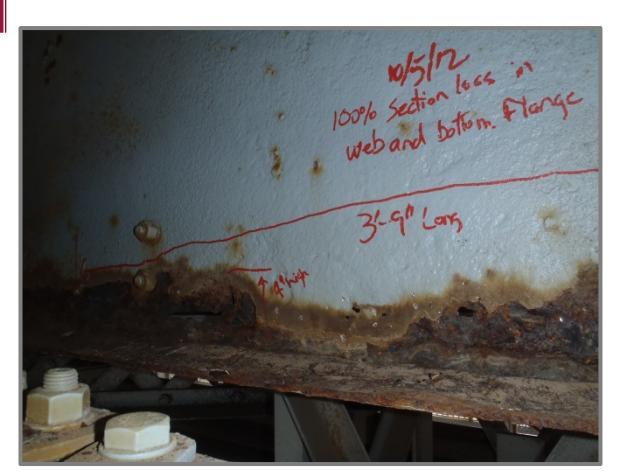
Photo 21 – Stringer P between Floorbeams 20 and 21 with 100% section loss in web and bottom flange.

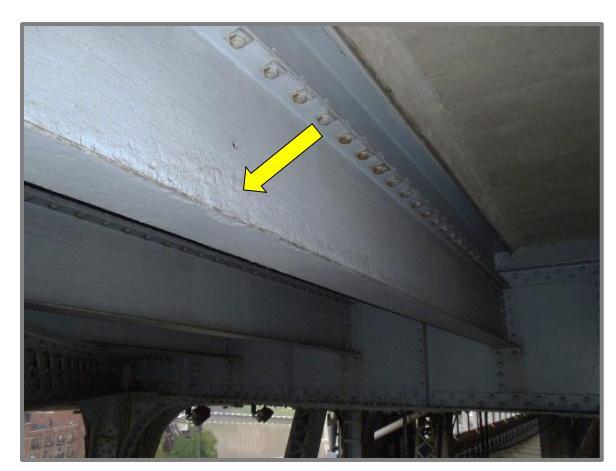
Photo 22 – Controlling Stringer H between Floorbeams 21 and 22. Note losses to web and bottom flange of original stringer.

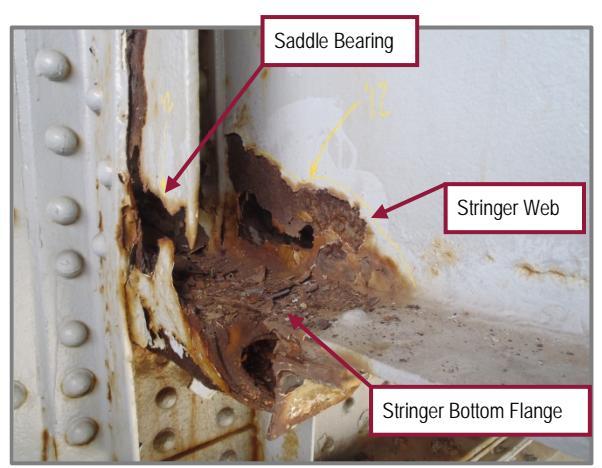
The lower deck stringers comprise of two unique sections, original Bethlehem 24"x84# I-sections and new W24x68 rolled sections from the 1994 Rehabilitation. The most significant section losses occurred at the stringer ends at saddle bearing locations, where 100% section loss was commonly noted in stringer webs and bottom flanges (see Photo 24).

Photo 24 – Lower deck Stringer 10 at west face Floorbeam 21 saddle bearing. Note 100% section loss on the stringer web and bottom flange, as well as the saddle bearing.

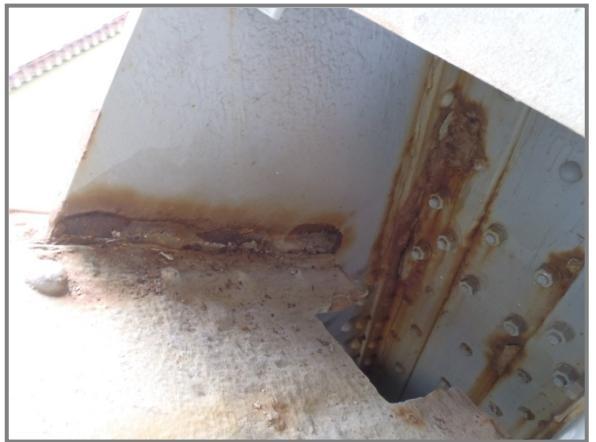
Photo 27 – Typical gusset plate section loss along bottom chord (L2 of the South Truss shown).
