# **CUYAHOGA RIVER RESTORATION - BOSTON MILLS NORTH**

## **STANDARD PERMIT PRECONSTRUCTION NOTIFICATION**

May 2023

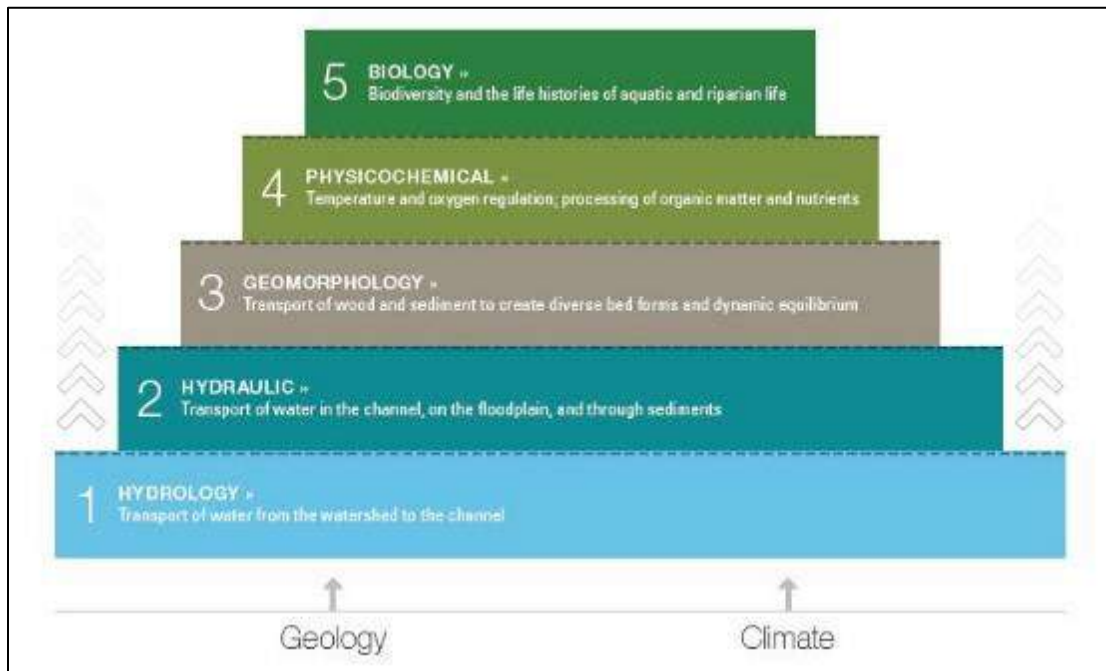
Figure 1: USEPA Stream Functions Pyramid

A heuristic lens to conceptualize this framework is the USEPA’s (2012) stream functions pyramid, which operationalizes stream functions in a hierarchical structure (Figure 1). The two forcing factors of geology and climate underlie the base functions of the pyramid. Hydrology

(Tier 1), then supports the higher tier functions in sequence — hydraulics (Tier 2), geomorphology (Tier 3), physicochemical (Tier 4), and biological (Tier 5).

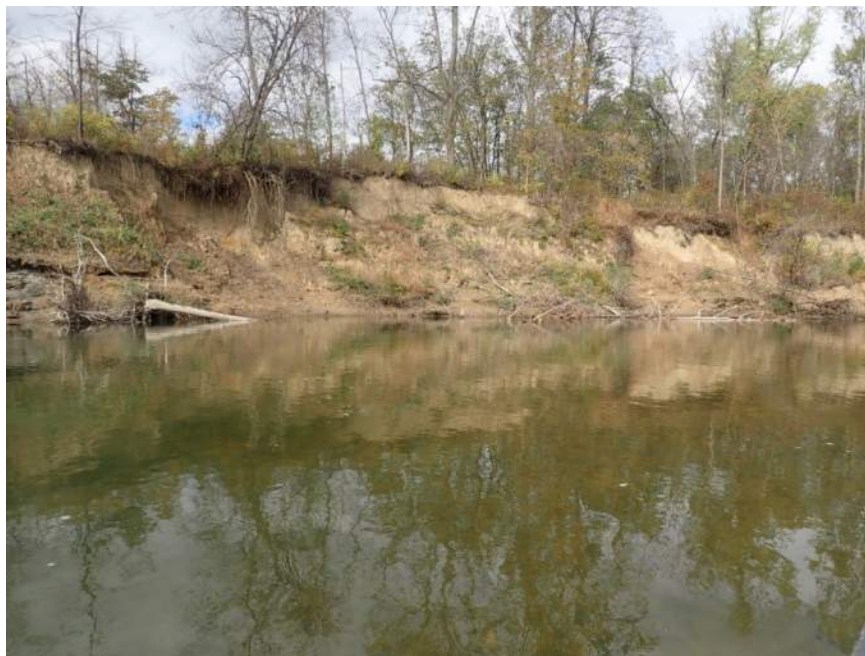
Figure 3: Example bank erosion along Cuyahoga River

Excessive channel erosion and bank instability along the Cuyahoga River was qualitatively assessed through several site visits to the CVNP. All observed reaches showed a considerable amount of erosion. In most cases the typical bank condition is characterized by vertical or near-vertical banks with bare, exposed soil (Figure 3).

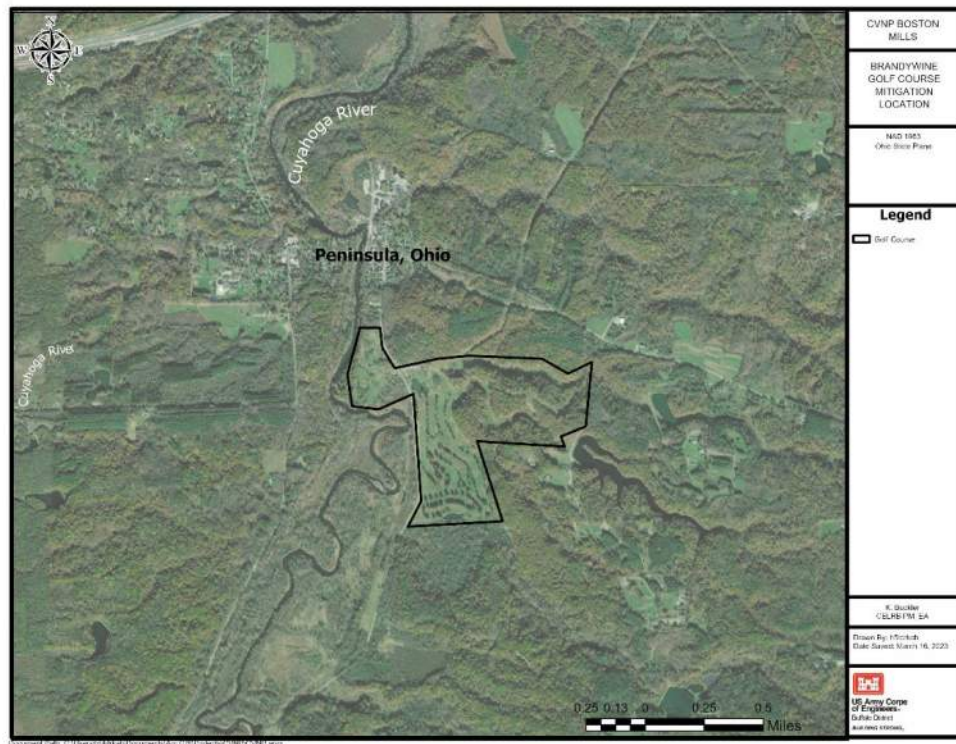
Figure 13: Compensatory mitigation location at Brandywine Golf Course

Compensatory mitigation is required to offset the loss of Category 3 wetlands and about 800 linear feet of Brandywine Creek, which is a perennial tributary to the Cuyahoga River. The compensatory mitigation proposal will take place at the Brandywine Golf Course, located in Peninsula, Ohio (Figure 13). The mitigation proposal is explained in the following sections.

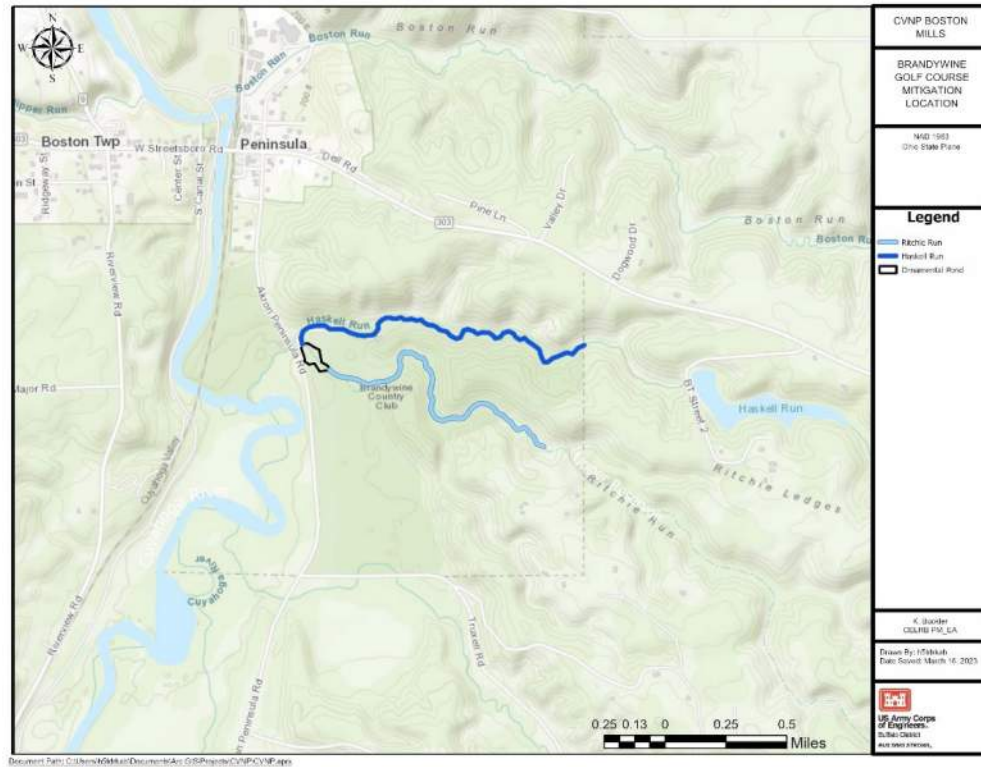
The Brandywine Golf Course, now owned by the National Park Service, was constructed in the 1960s during a time in American history when the importance of small streams was not recognized and development usually resulted in burying or channelizing many small tributaries. Two such tributaries at the Brandywine Golf Course, Haskell Run and Ritchie Run, flow through the property from east to west before converging and then flowing directly into the Cuyahoga River (Figure 14). Both tributaries are characterized as upper perennial riverine systems which have been modified and degraded by the construction and operation of the Brandywine Golf Course. This CMP focuses on restoring the Ritchie Run tributary.

Figure 14: Location of tributaries Haskell Run and Ritchie Run on the Brandywine Golf Course property

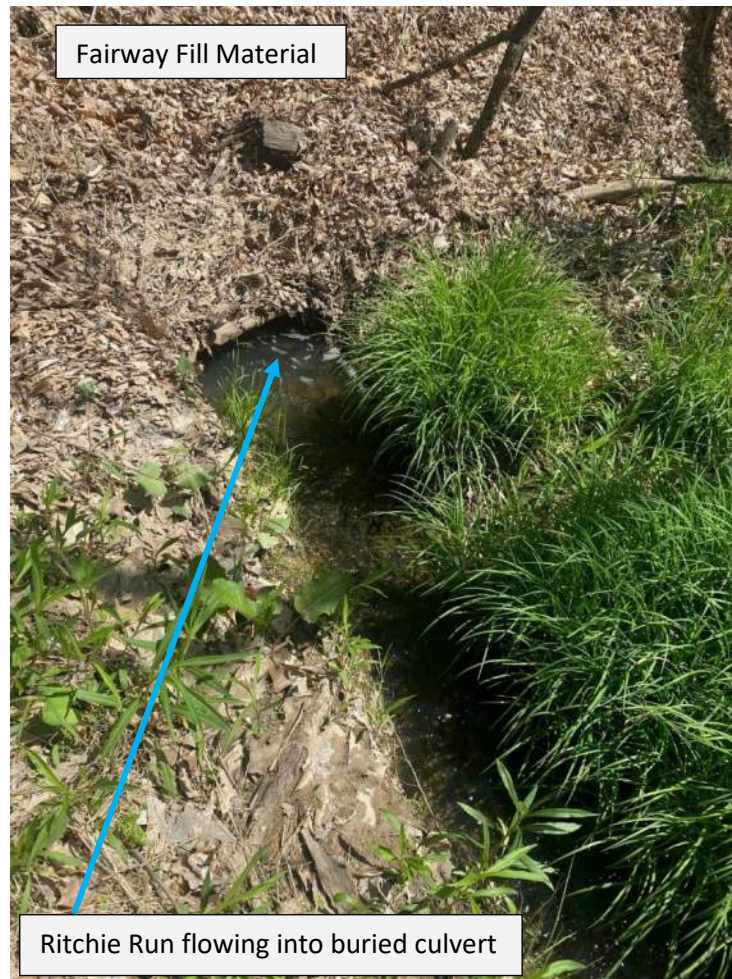
Figure 15: Ritchie Run flowing into buried culvert

To develop the golf course, about 90 percent of the Ritchie Run stream channel was buried in a culvert. Fill material was then brought in to construct a fairway over the former stream channel. This fill was used to raise, grade, and flatten the Ritchie Run valley. Figure 15 shows Ritchie Run flowing into the buried culvert with about three feet of fill material above the culvert. This fill material forms the fairway. This buried condition continues unbroken for about 3,500 linear feet until the culvert empties into an inline ornamental pond (Figure 14). Ritchie Run then confluences with Haskell Run before emptying into the Cuyahoga River. Figure 16 shows the reference condition of Ritchie Run just upstream of the buried section, which is a meandering channel with access to a sedge/grass meadow floodplain and an open forest riparian corridor.

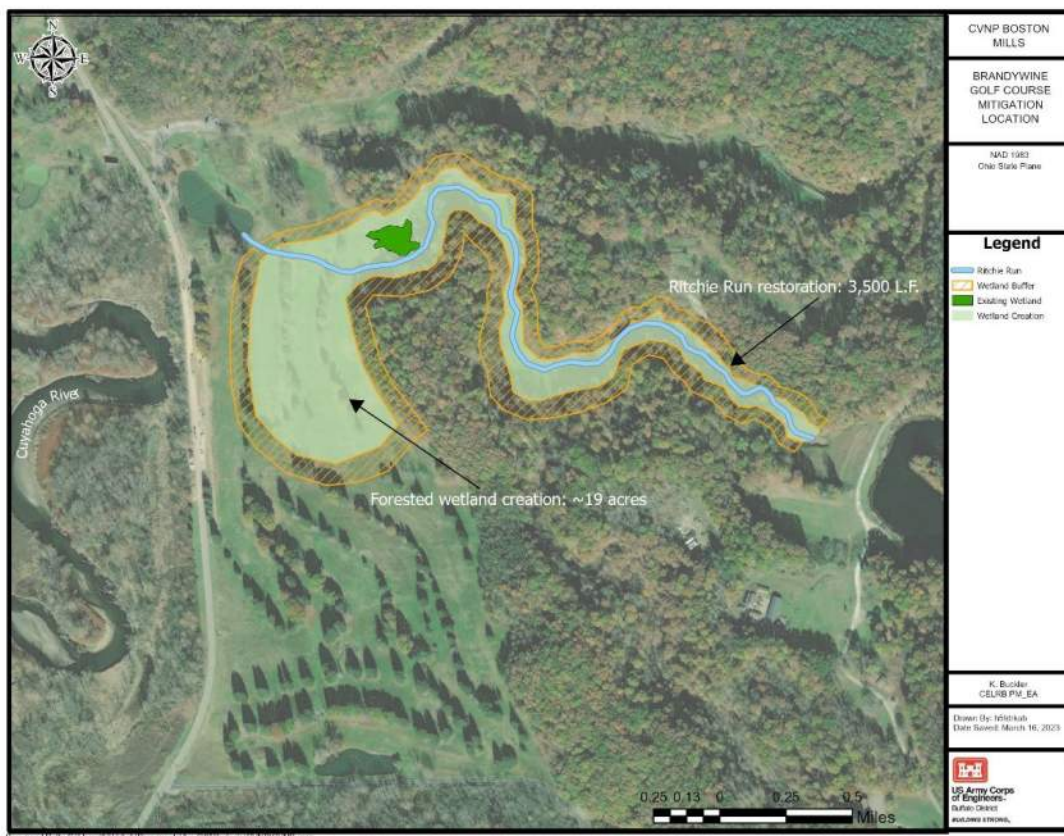
Figure 17: Conceptual mitigation proposal at Ritchie Run, on Brandywine Golf Course

The CMP at the former Brandywine Golf Club would involve restoring about 3,500 linear feet of stream channel and about 15-20 acres of forested riparian wetland (Figure 17). The stream restoration component of the CMP would be to daylight the entire buried channel of Ritchie Run. The fill material used to construct the fairway would also be excavated down to an elevation sufficient to support riparian and floodplain wetlands. The daylighted section of Ritchie Run would be constructed to follow, as closely as possible, its historic alignment prior to construction of the golf course. The new channel would also be designed to match the upstream reference conditions shown in Figure 16 constructed as a two-stage channel with a floodplain bench and instream habitat structures using large woody debris.
