Cuyahoga County
Animal Shelter

Fire Damper Inspection Report

Report Date: November 3, 2025

Project: Cuyahoga County
Animal Shelter

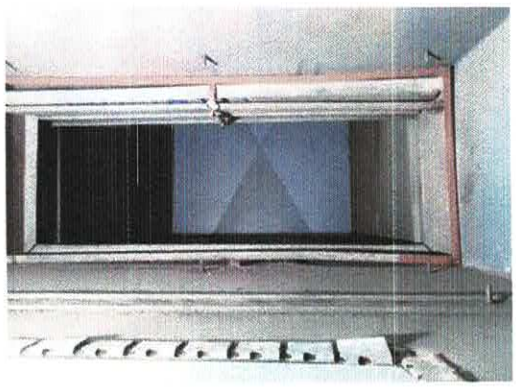
Picture of Damper in Open Position

Comments / Corrections
None

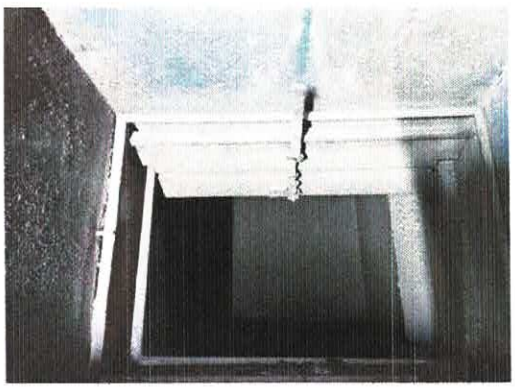
Picture of Damper in Open Position

Comments / Corrections
None

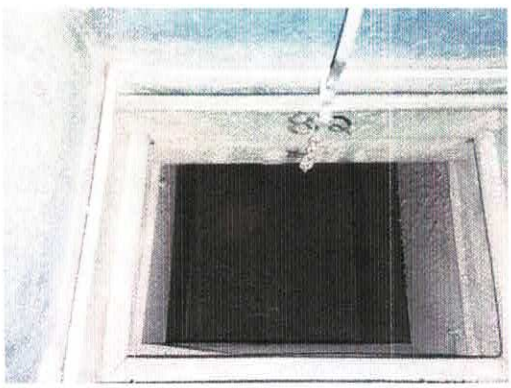
Picture of Damper in Open Position

Comments / Corrections
None

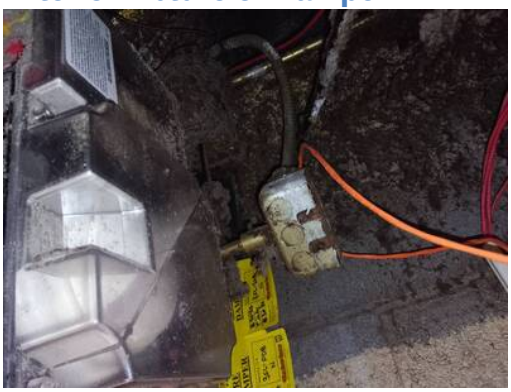
Exterior Picture of Damper

Comments / Corrections
None

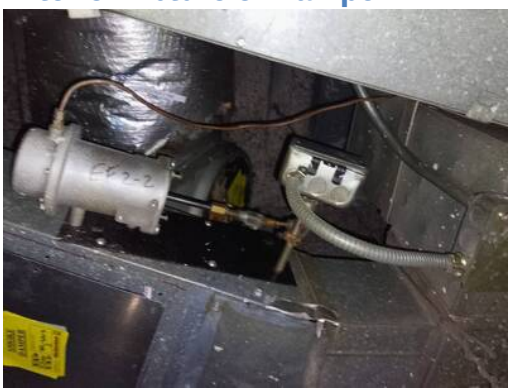
Comments / Corrections
Abandoned per JCI. Passed visual inspection.

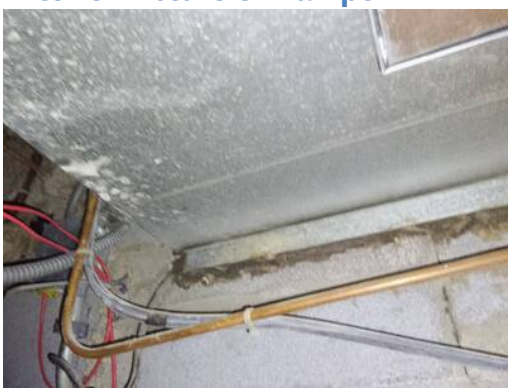
Comments / Corrections
No Angle. No breakaway connection.

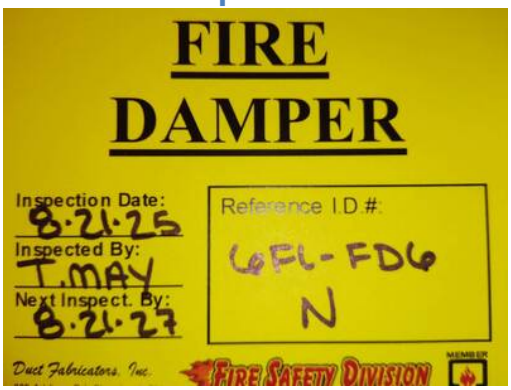
Pass / Fail / Abandoned
Fail

Comments / Corrections
No annular space. Improper installation of angle. No space between dampers.

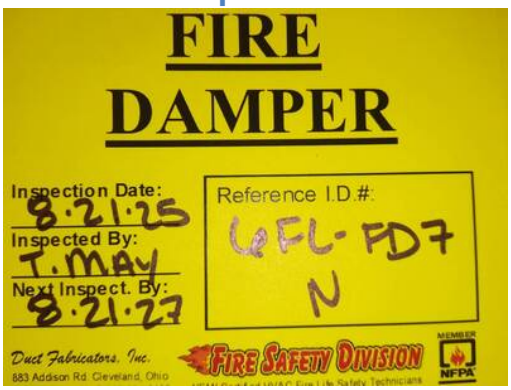
Pass / Fail / Abandoned
Fail

Comments / Corrections
No breakaway connection. Not enough space between dampers. Improper installation of angle.

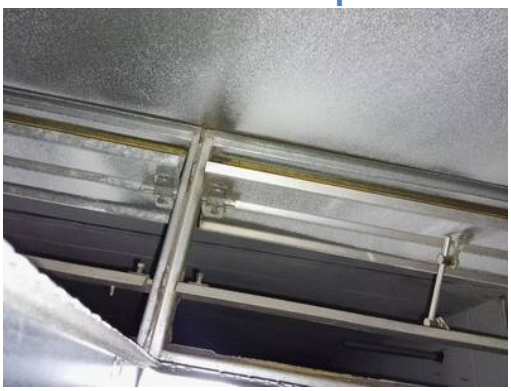
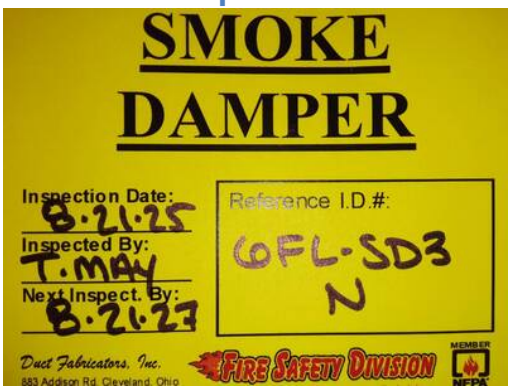
Pass / Fail / Abandoned
Fail

Comments / Corrections
More than 2' away from fire rated wall.
Found in closed position.

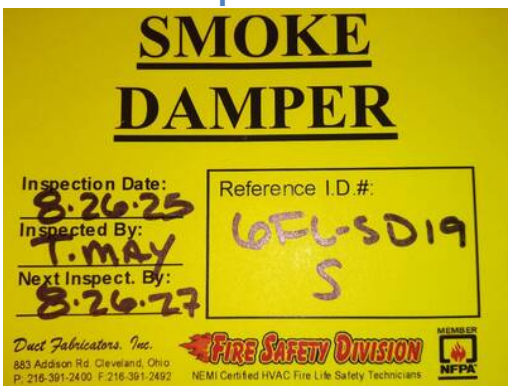
Comments / Corrections
Damper found closed.

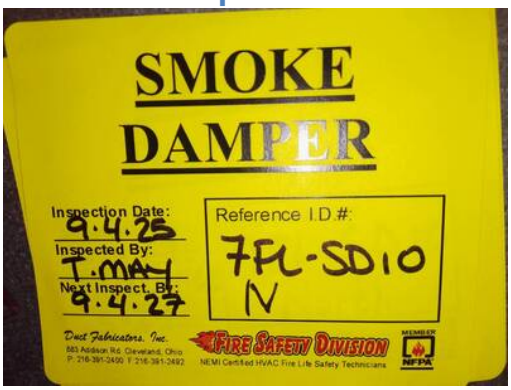
Comments / Corrections
Damper found closed.

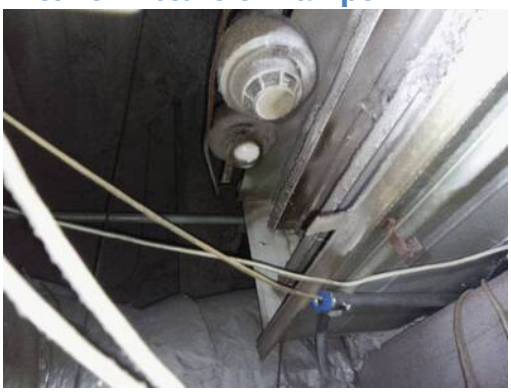
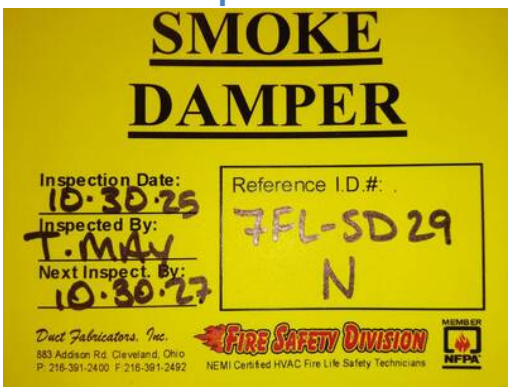
Comments / Corrections
None

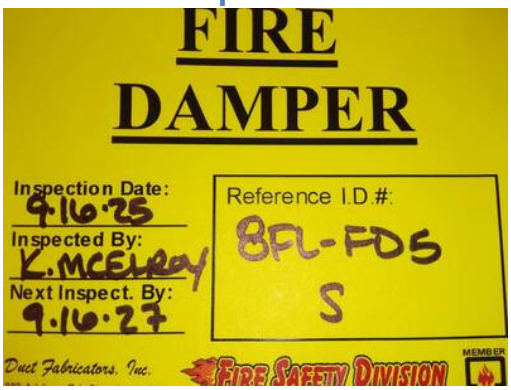
Pass / Fail / Abandoned
Fail

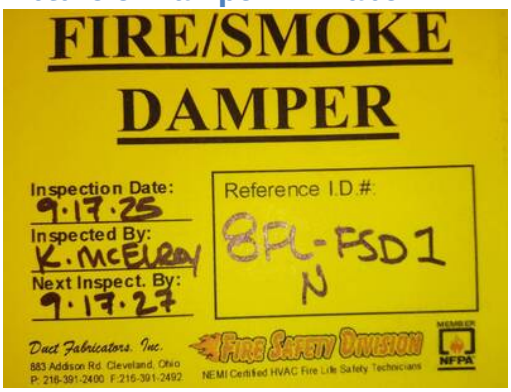
Pass / Fail / Abandoned
Fail

Comments / Corrections
Damper found closed, actuator needs replaced.

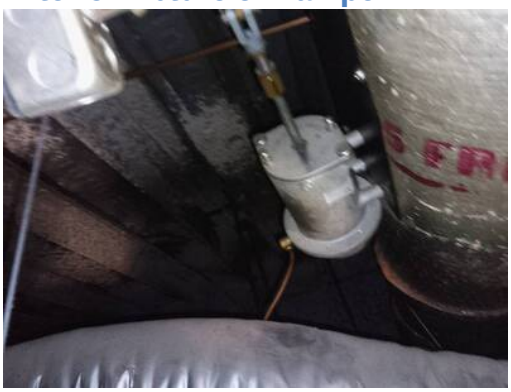
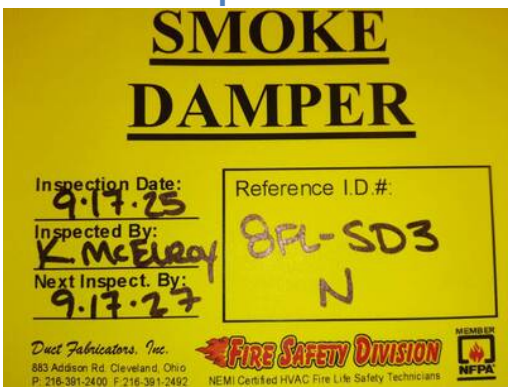
Comments / Corrections
None

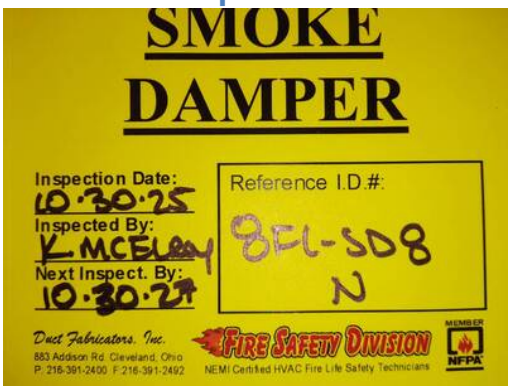
Comments / Corrections
Damper found closed.

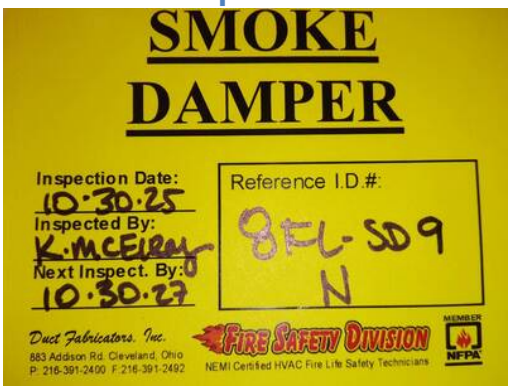
Pass / Fail / Abandoned
Pass

Comments / Corrections
Damper found closed

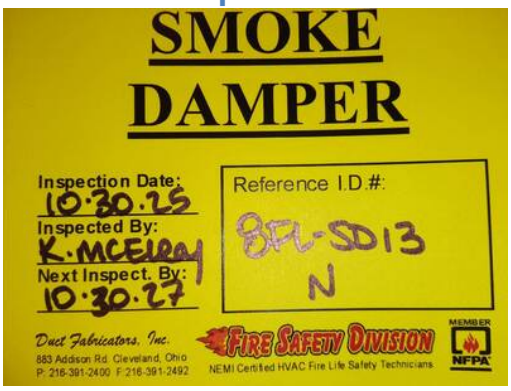
Pass / Fail / Abandoned
Fail

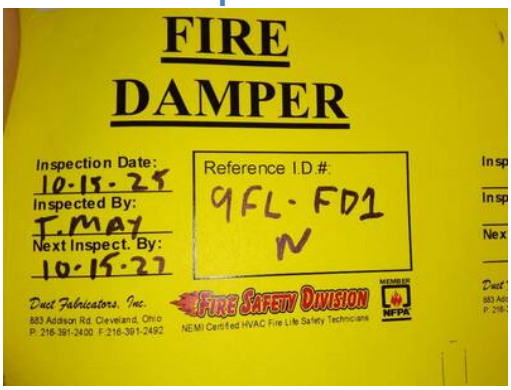
Pass / Fail / Abandoned
Fail

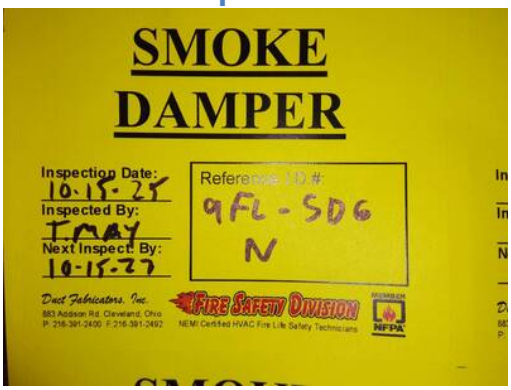
Pass / Fail / Abandoned
Fail

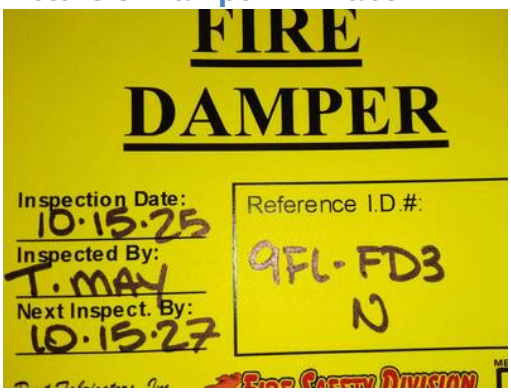
Pass / Fail / Abandoned
Fail

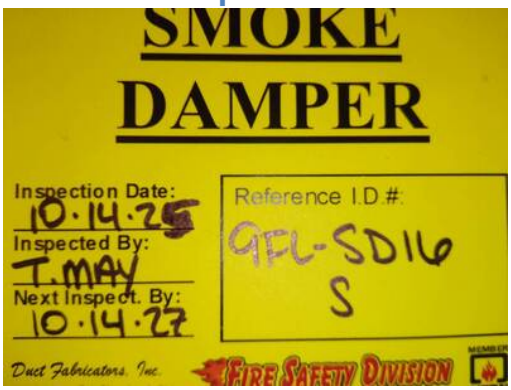
Pass / Fail / Abandoned
Fail

Comments / Corrections
Damper found closed.

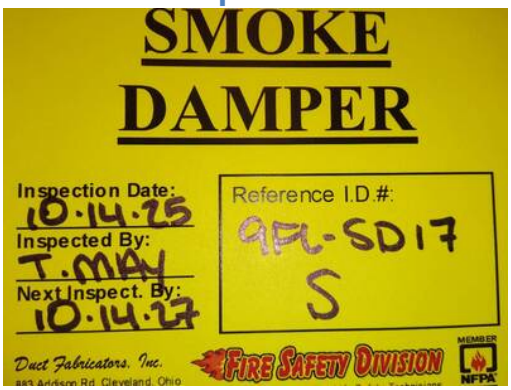
Pass / Fail / Abandoned
Fail

Comments / Corrections
Damper found closed.

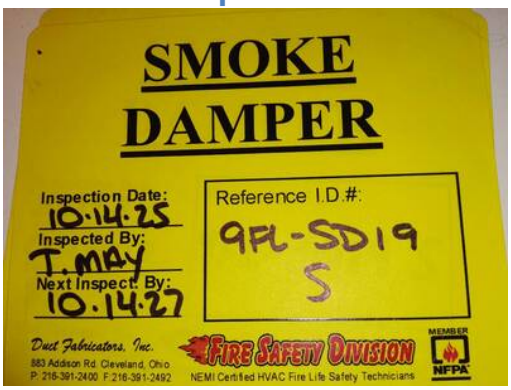
Pass / Fail / Abandoned
Fail

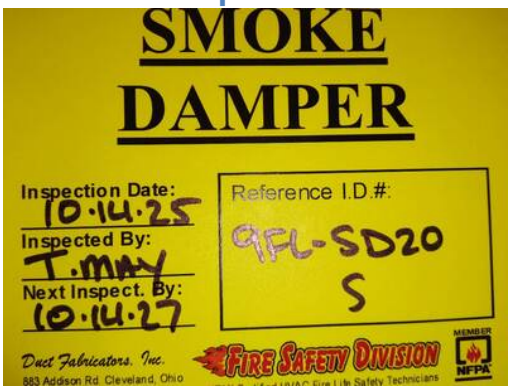
Pass / Fail / Abandoned
Fail

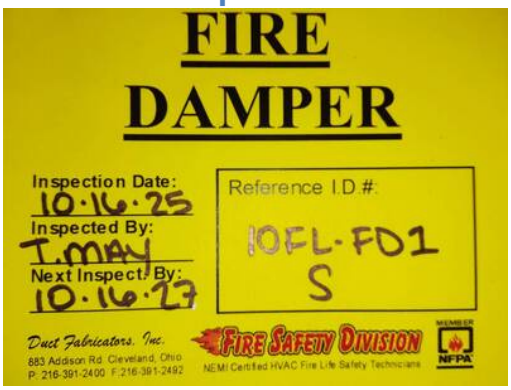
Pass / Fail / Abandoned
Fail

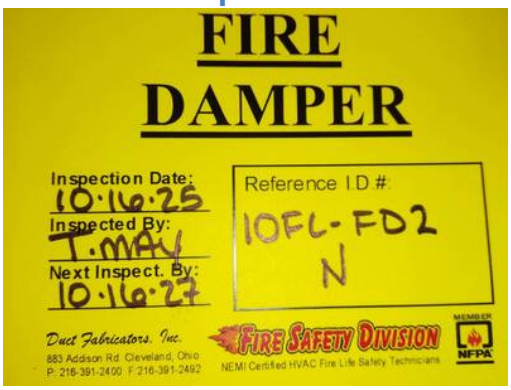
Pass / Fail / Abandoned
Fail

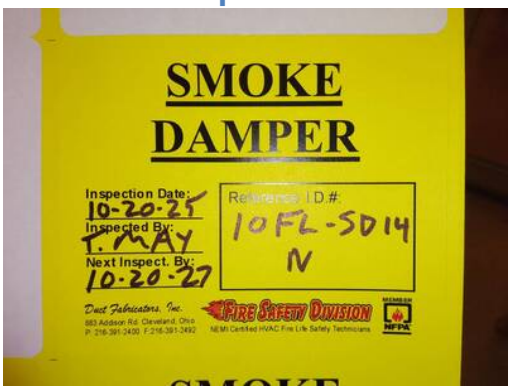
Comments / Corrections
Damper found closed.

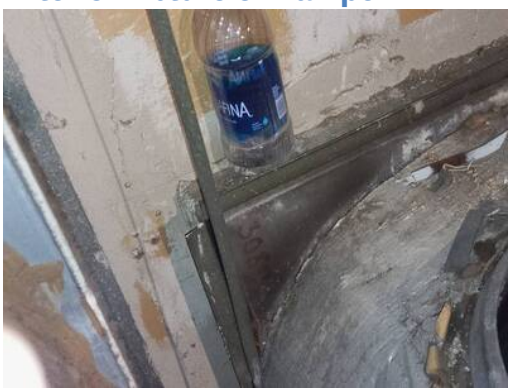
Comments / Corrections
Damper not in wall, no angle

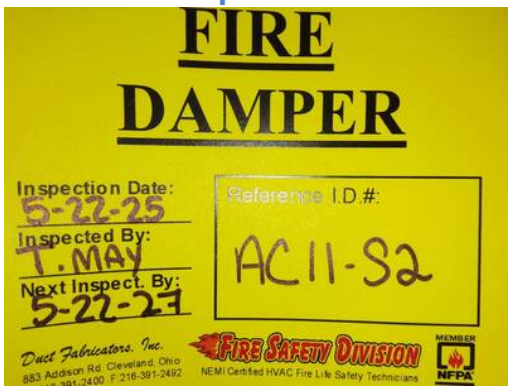
Comments / Corrections
No sleeve or angle. Access to back, can be replaced with in or out of wall damper.

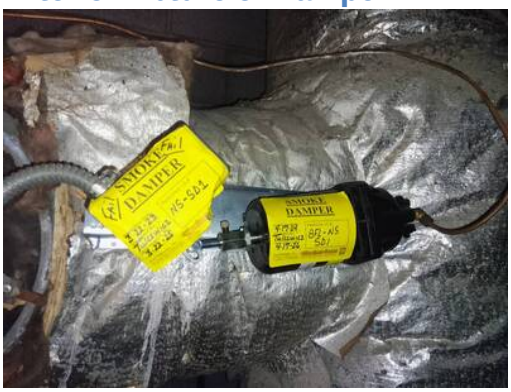
Comments / Corrections
Labeled as fail from prior inspection.

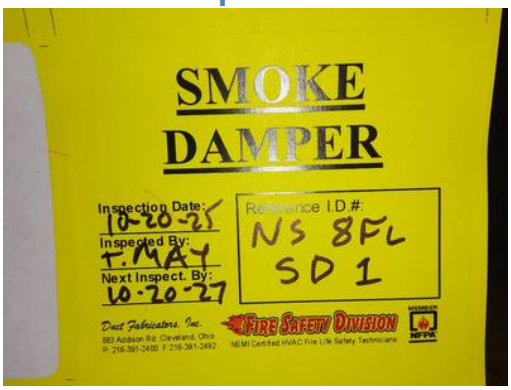
Pass / Fail / Abandoned
Fail

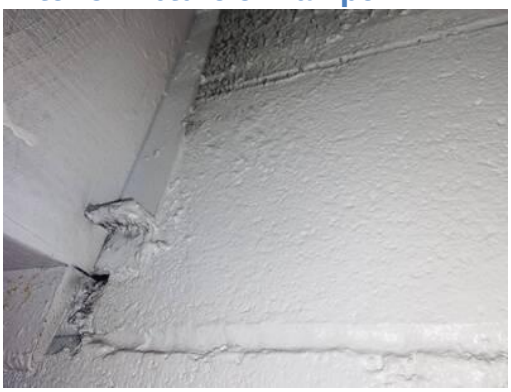
Pass / Fail / Abandoned
Pass

Comments / Corrections
Welded angle per manufacturer instructions

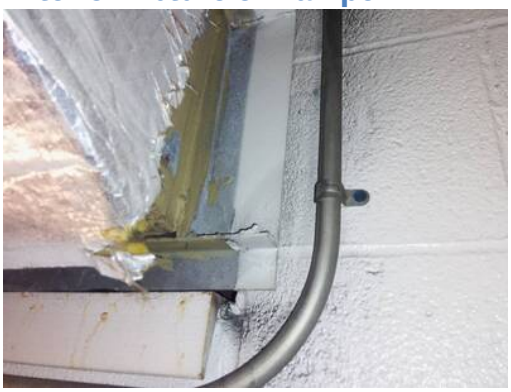
Pass / Fail / Abandoned
Pass

Comments / Corrections
Welded angle per manufacturer instructions

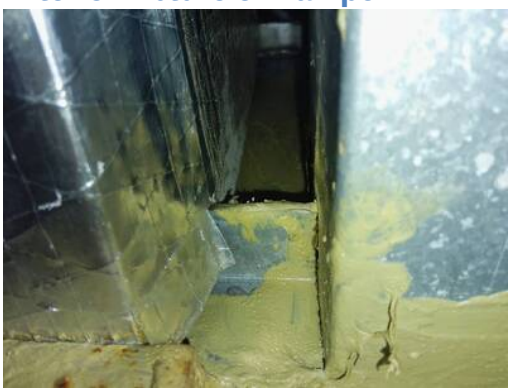
Pass / Fail / Abandoned
Pass

Comments / Corrections
Welded angle per manufacturer instructions

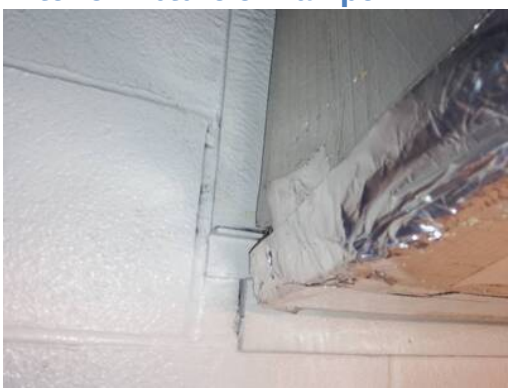
Pass / Fail / Abandoned
Pass

Comments / Corrections
Welded angle per manufacturer instructions

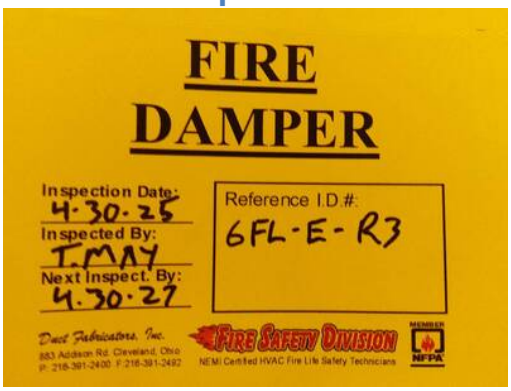
Pass / Fail / Abandoned
Fail

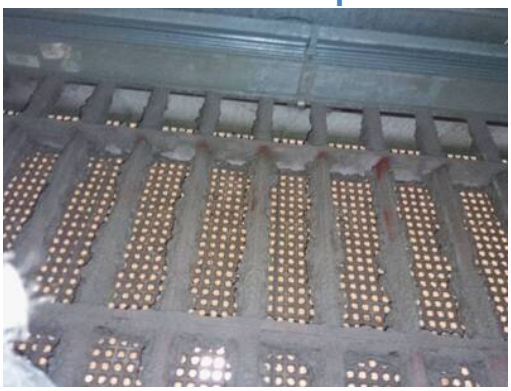
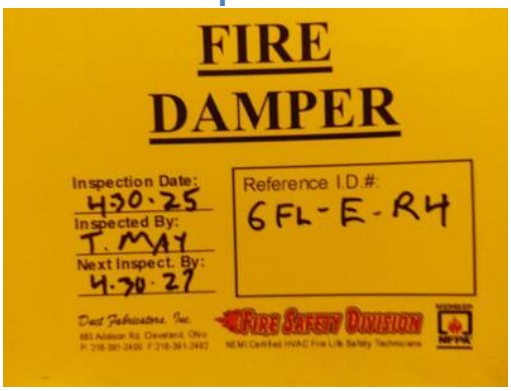
Pass / Fail / Abandoned
Fail

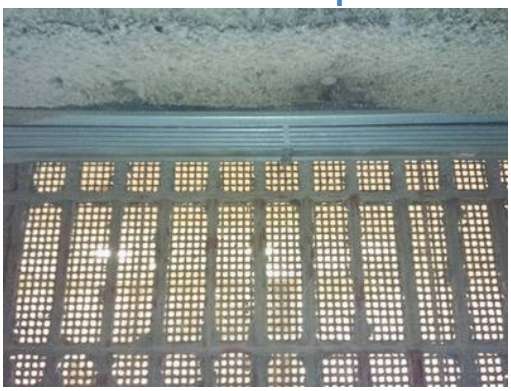
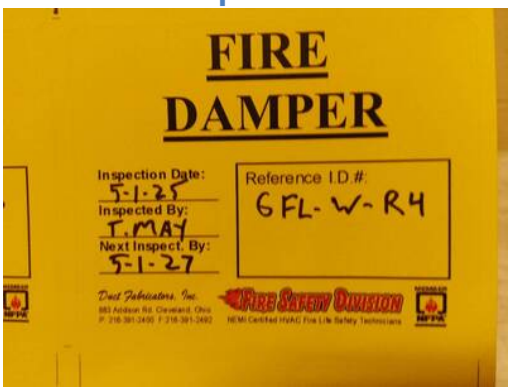
Pass / Fail / Abandoned
Fail

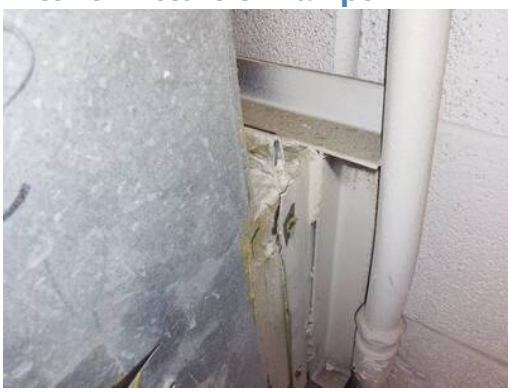
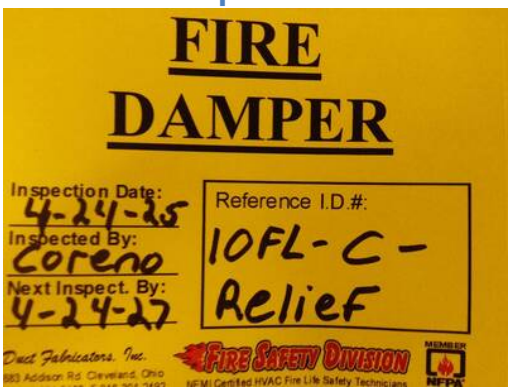
Pass / Fail / Abandoned
Pass

Comments / Corrections
None

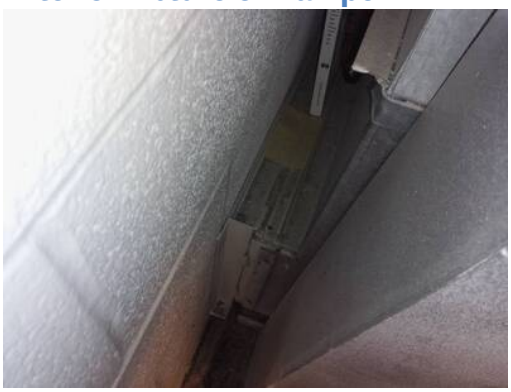
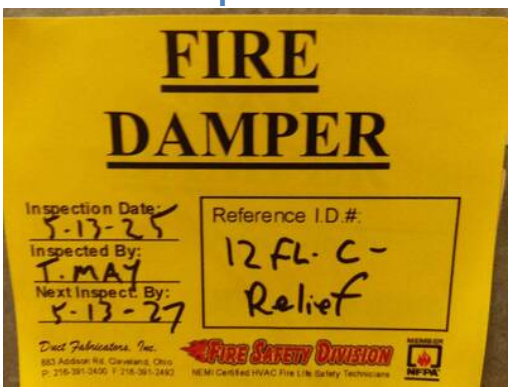
Pass / Fail / Abandoned
Fail

Comments / Corrections
Damper not in wall

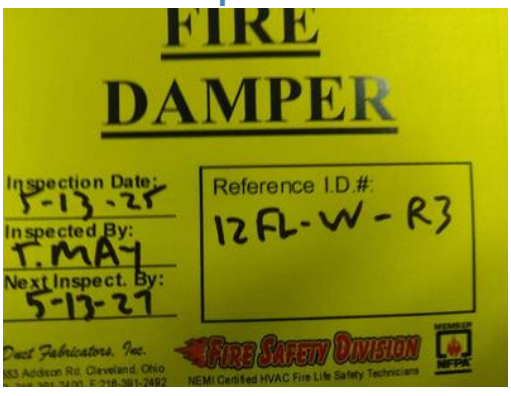
Pass / Fail / Abandoned
Fail

Comments / Corrections
Improper angle, screws in track. Need 3*3 and fire caulk

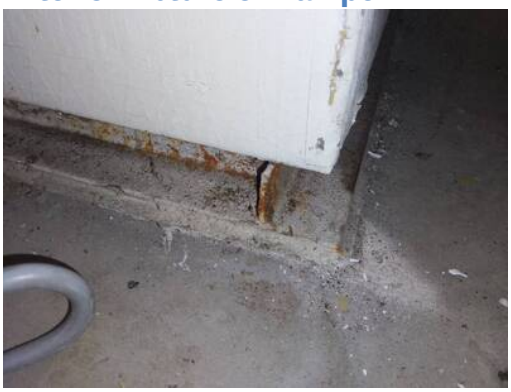
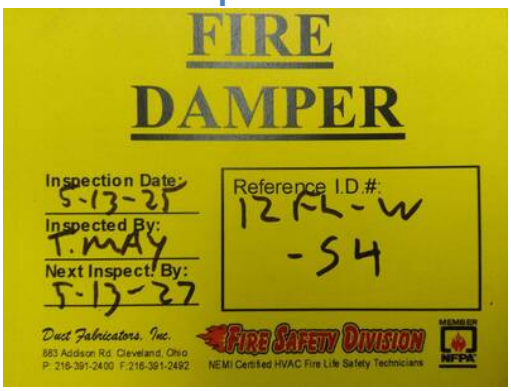
Pass / Fail / Abandoned
Pass

Comments / Corrections
None

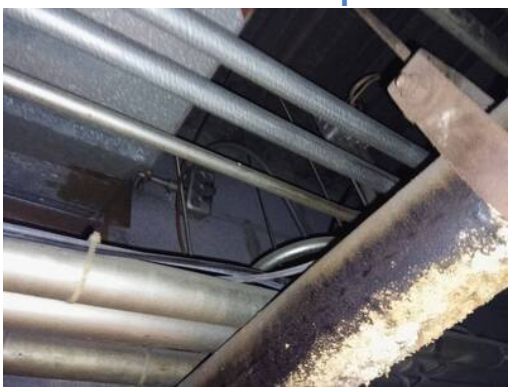
Comments / Corrections
Electrical piping blocks access to damper.

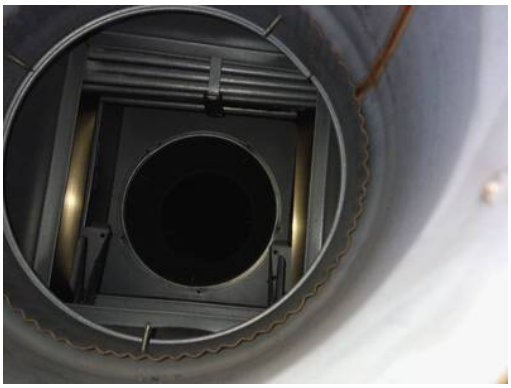
Comments / Corrections
. Take off canvas to inspect

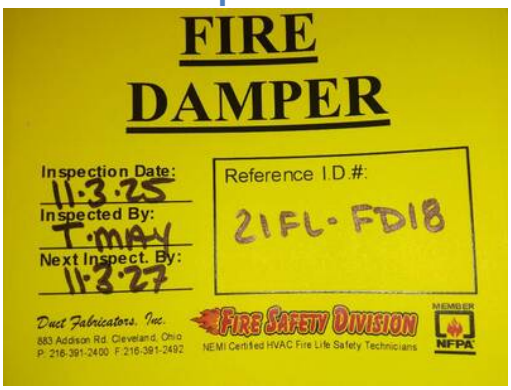
Pass / Fail / Abandoned
Fail

Comments / Corrections
Improper installation of angle.

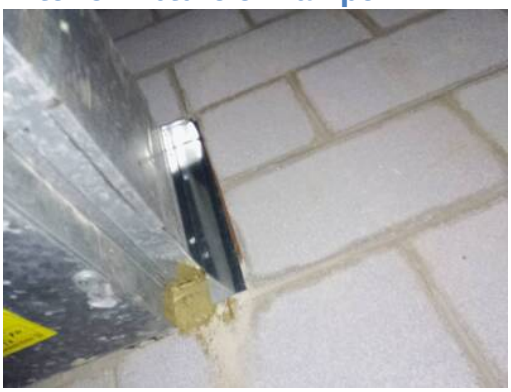
Exterior Picture of Damper

Pass / Fail / Abandoned
Fail

Comments / Corrections
No breakaway connection.

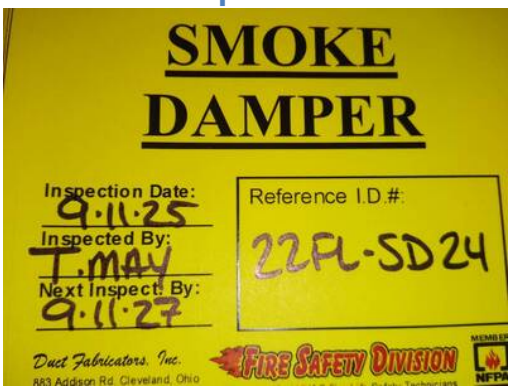
Pass / Fail / Abandoned
Fail

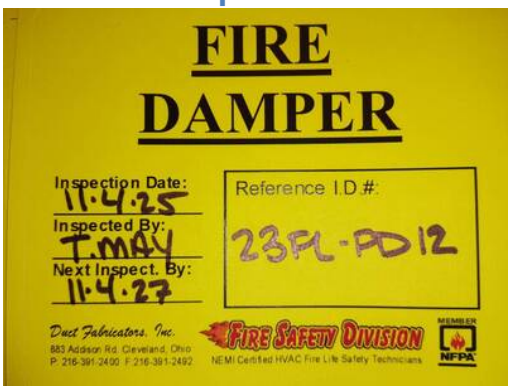
Pass / Fail / Abandoned
Fail

Comments / Corrections
Improper installation of angle.

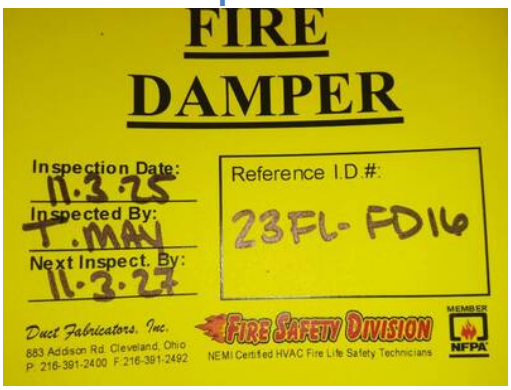
Pass / Fail / Abandoned
Fail

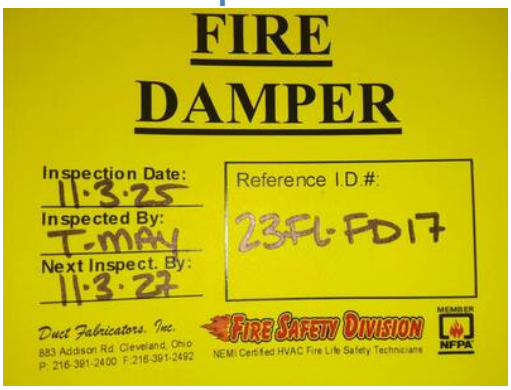
Pass / Fail / Abandoned
Fail

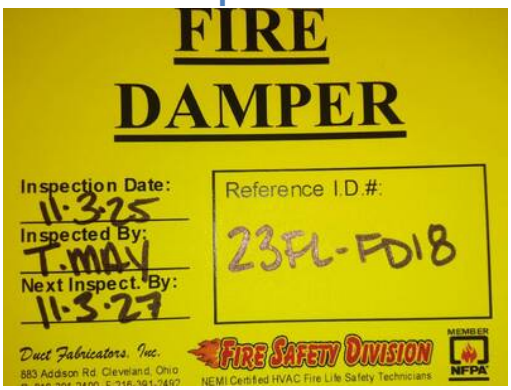
Pass / Fail / Abandoned
Fail

Comments / Corrections
Improper installation of angle.

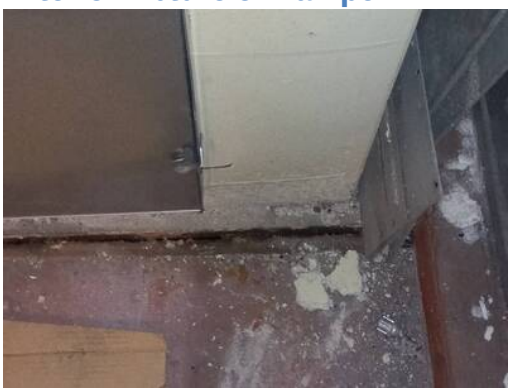
Exterior Picture of Damper

Pass / Fail / Abandoned
Fail

Comments / Corrections
No angle, no sleeve, damper in floor

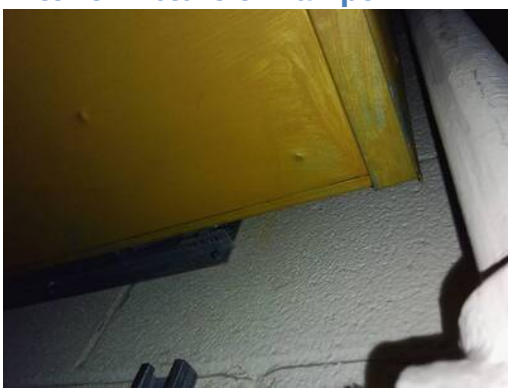
Comments / Corrections
Angle on back

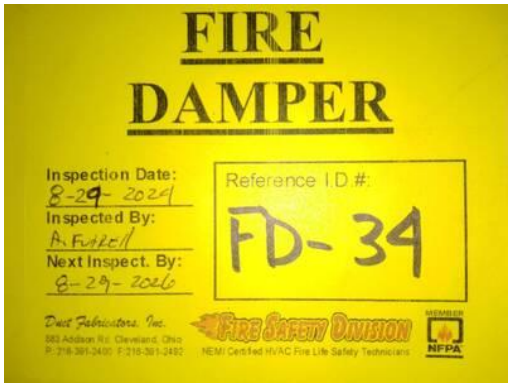
Comments / Corrections
Installed access door & link. Damper was found in closed position

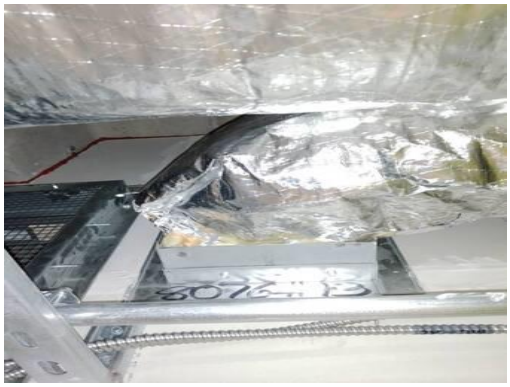
Pass / Fail / Abandoned
Fail

Comments / Corrections
None

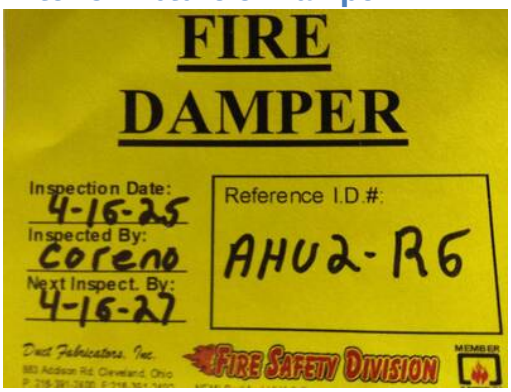
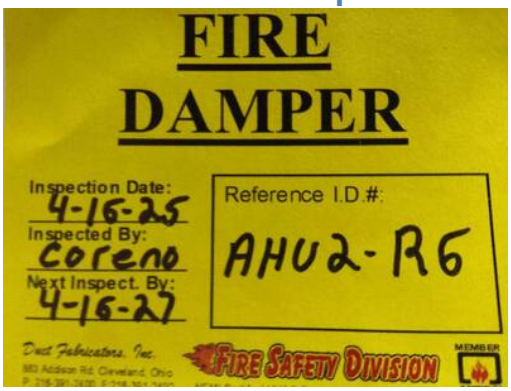
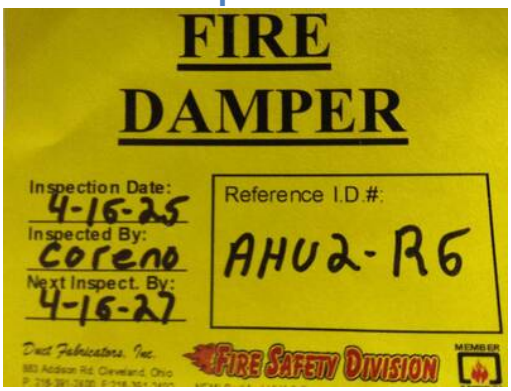
Pass / Fail / Abandoned
Abandoned

Comments / Corrections
Was removed during renovation of D & E Wing

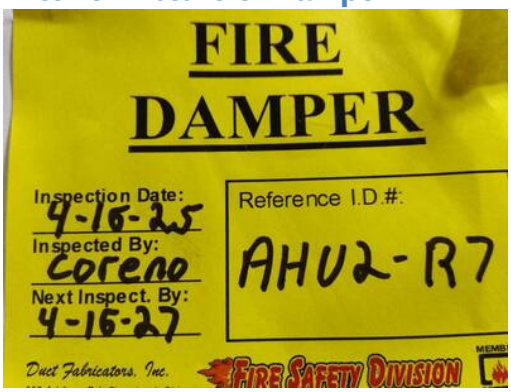
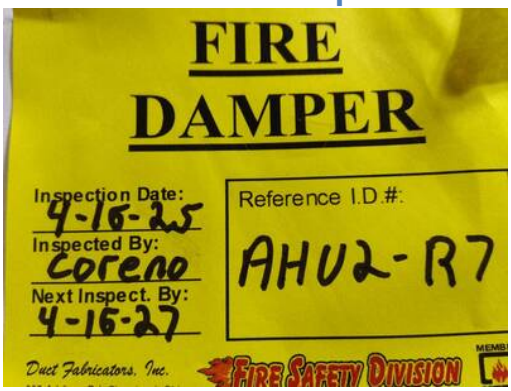
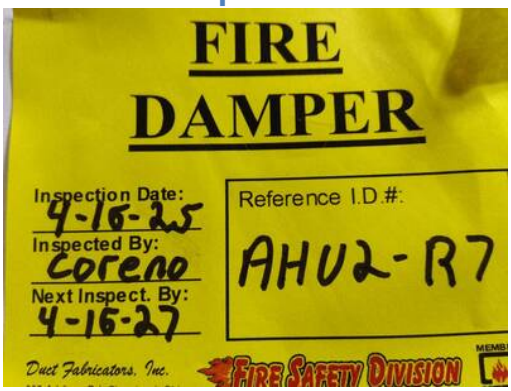
Pass / Fail / Abandoned
Abandoned

Comments / Corrections
Was removed during renovation of D & E Wing

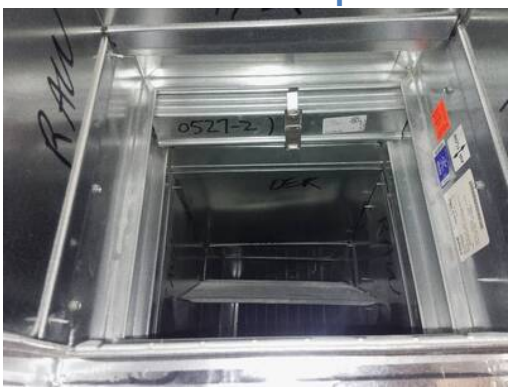
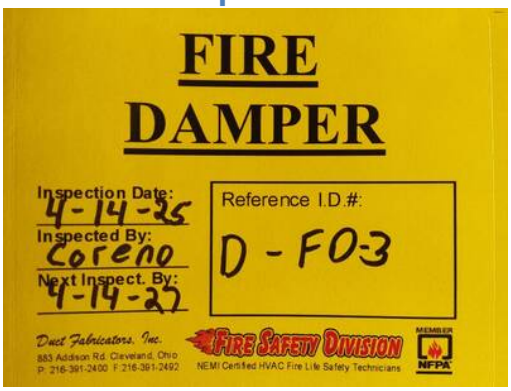
Comments / Corrections
1st FL D Wing. Tile is to tight to access doors & it will damage ceiling tile & grid.

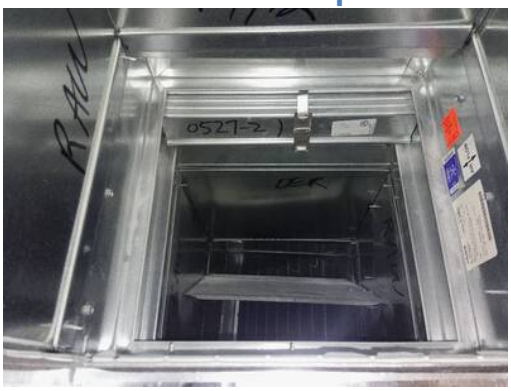
Comments / Corrections
1st FL D Wing. Tile is way tight to access doors. It will damage grid & tile.

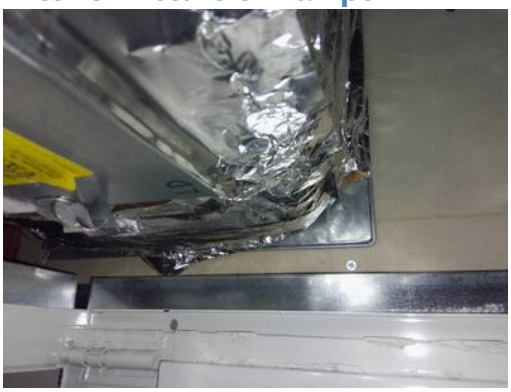
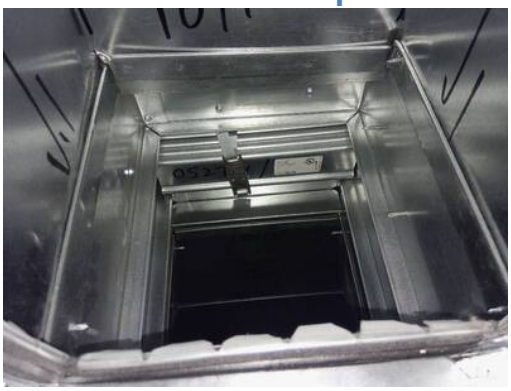
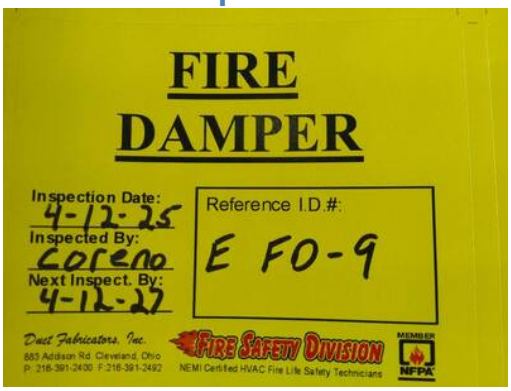
Comments / Corrections
1st FL E Wing

Pass / Fail / Abandoned
Pass

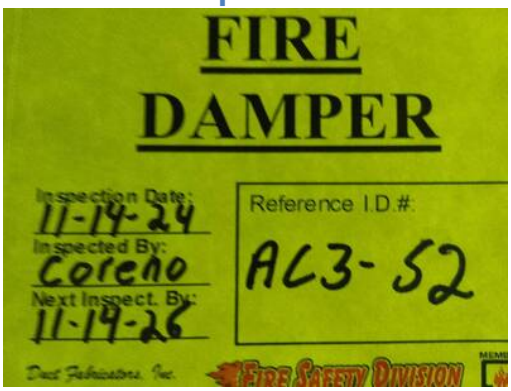
Pass / Fail / Abandoned
Fail

Comments / Corrections
Broken spring

(174) dampers passed visual inspection
(1) damper failed due to reasons indicated on the report
(1) damper was replaced (AC3-S2) on 1/20/25 due to broken spring
Physical report has been provided

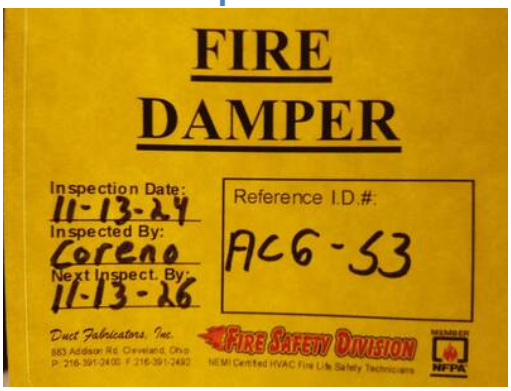
Pass / Fail / Abandoned
Fail

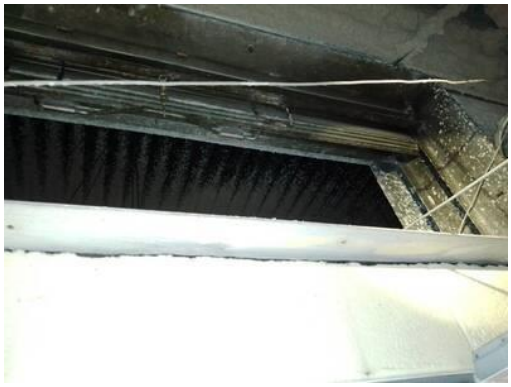
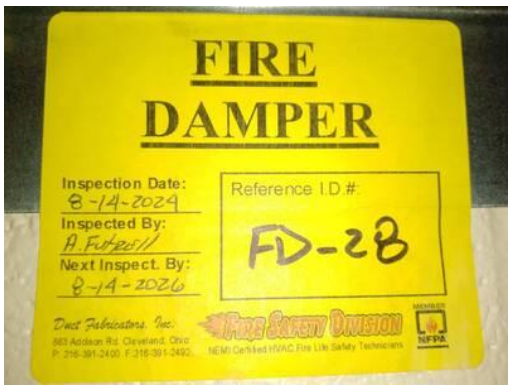
Pass / Fail / Abandoned
Fail

Comments / Corrections
Communication cables going through damper, an added retaining angle.
