### Underwater Inspection Report for:

Highland Road Over the Cuyahoga River, Summit County, Ohio

(Prestressed Concrete Box Beams on Capped Pile Bents and Abutments)

Report Prepared Date: June 12, 2026

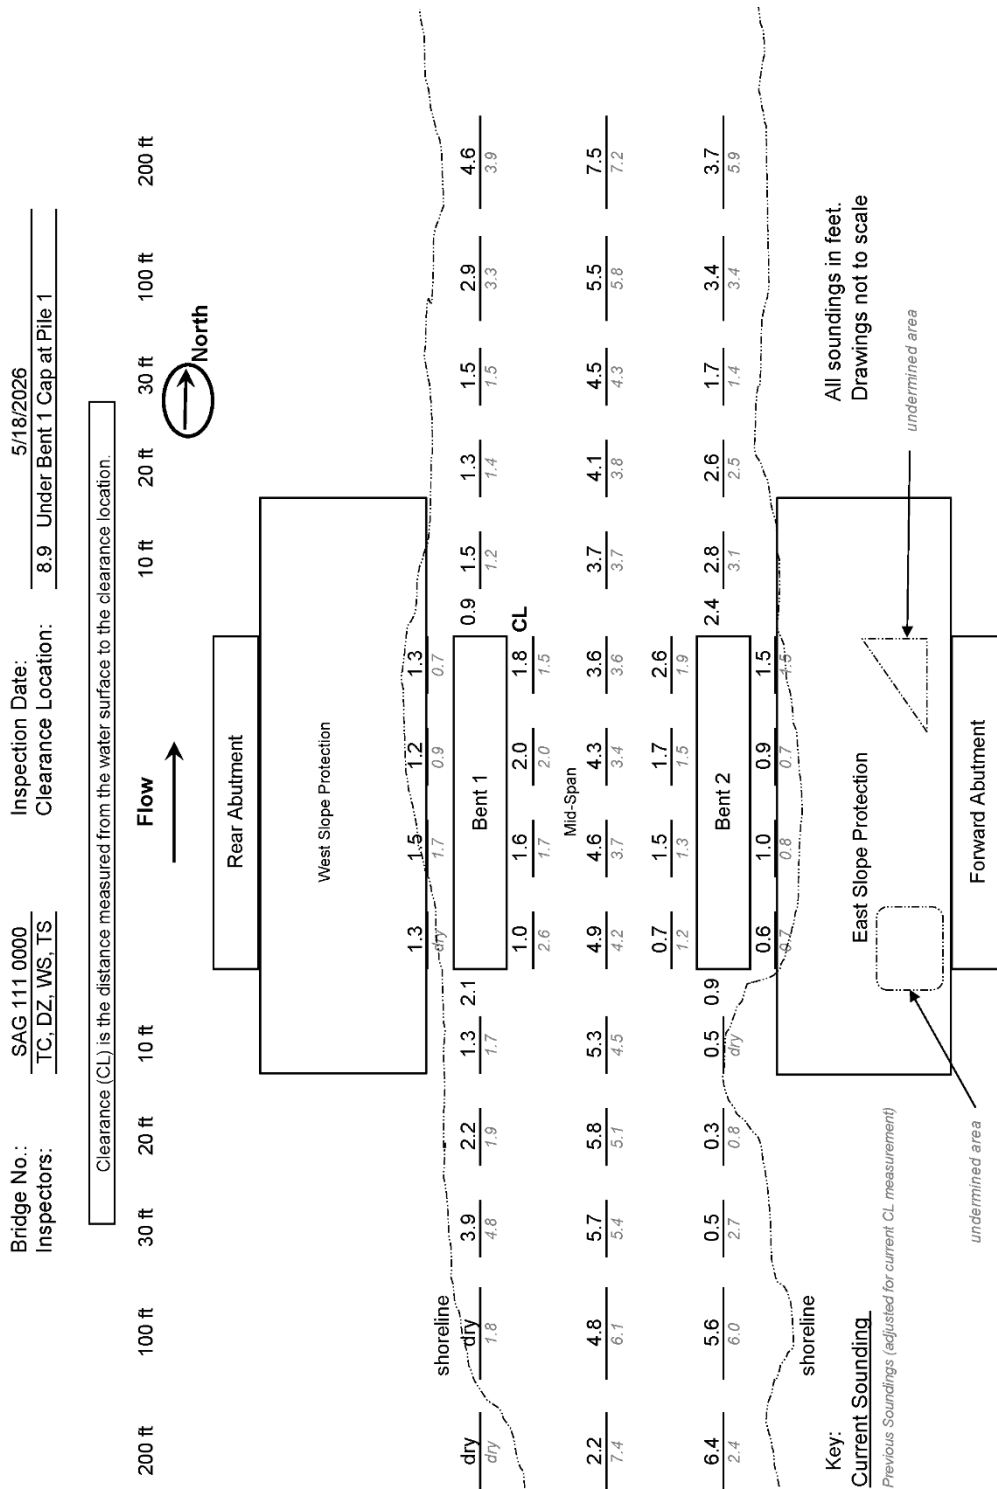
## 8 SOUNDINGS

- There is one missing hose clamp at Pile 1.
- The concrete slope protection at this abutment has numerous cracks up to 1/8", 1" deep scaling along the waterline, and some vegetation growing in the joints (see *Photo 12*).
- A 12' x 8' triangular area in the northeast corner bounded by a 1/8" crack, is hollow sounding when struck with a hammer (see *Photos 12 & 13 and Sounding Sheet* for location). Probing at the joint detected a 17-inch tall void under this section, due to undermining of the slab. The undermining has increased since the 2021 inspection (10" of undermining was measured in 2021).
- In the southeast corner of the slope protection under the bridge, there is an approximately 10' x 10' area that is hollow sounding when struck with a hammer, but no concrete deterioration was noted. (see *Sounding Sheet* for location).
