STRUCTURAL EVALUATION REPORT FOR LOWER DECK BIKE PATH CUYAHOGA COUNTY, OHIO

THE DETROIT-SUPERIOR BRIDGE BR#: CUY-6-1456 SFN: 1800930

Report Submitted: April 4, 2014

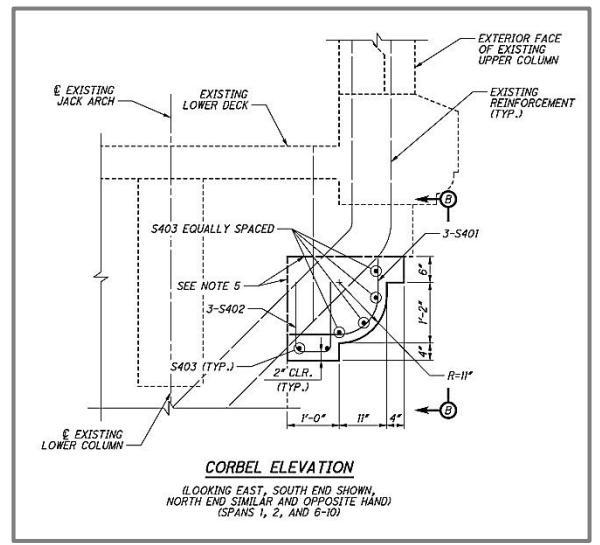
Figure 3 – Typical concrete corbel replacement detail from the 2014 Rehabilitation Plans.

The scope of work for this project as described in the plans includes patching of the upper deck wearing surface and concrete substructure and superstructure, concrete corbel replacement (see Figure 3), steel arch span zone painting, steel floorbeam web retrofits, drainage and sinkhole repairs, and inspection access improvements. Many of the spalled and delaminated concrete areas as described in this report will be repaired as part of this rehabilitation contract. The concrete repairs have been prioritized in order to ensure that members exhibiting major deficiencies or public safety risks are addressed. Only minor steel repairs and zone painting are being performed in Span 4 under this project.

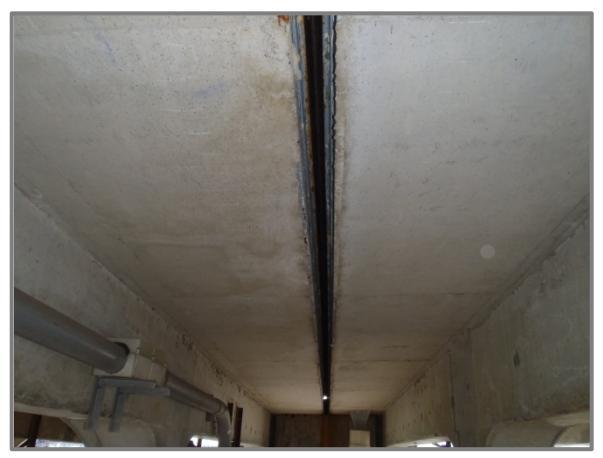
Photo 4 – Typical view of deck underside looking south at joint location between Spans 7 and 8.

Overall the condition rating of the concrete deck is controlled by West Approach station and tunnel sections of the structure, which were not included in the scope of this load rating. The deck components in the remaining spans are without major deficiencies (see Photo 4), with minor cracking in the deck floor in isolated locations. As a result, the as-inspected load ratings are governed by the as-built condition.

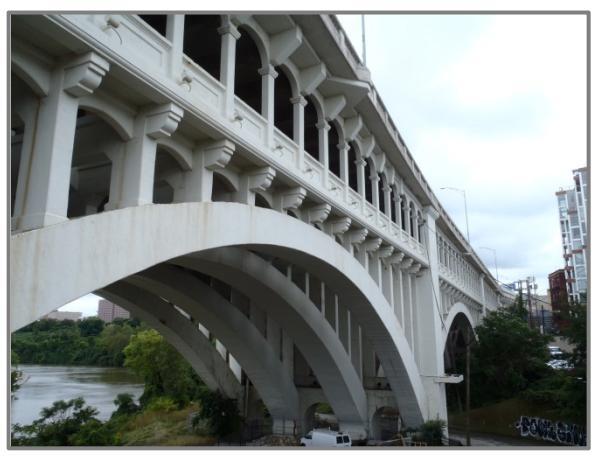
West Approach Spans 1 through 3 and East Approach Spans 5 through 13 consist of four concrete arch ribs supporting two concrete decks (see Photo 5). The top deck is the main traffic deck, carrying four vehicular lanes, as well as pedestrian loading on the north and south sides of the bridge. Originally intended for street railway traffic, the lower concrete deck has been closed to the public and is only periodically used as a multi-functional setting for the City of Cleveland.

Photo 5 – North elevation of concrete arch ribs in Span 3.

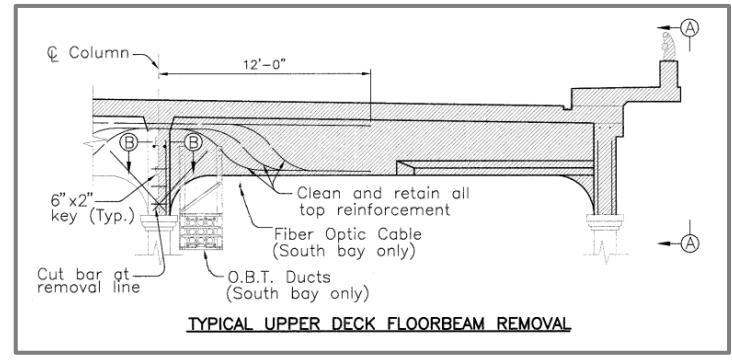
Figure 14 – Typical removal detail for concrete upper floorbeam during 1994 Rehabilitation. Note retained reinforcement adjacent to column.

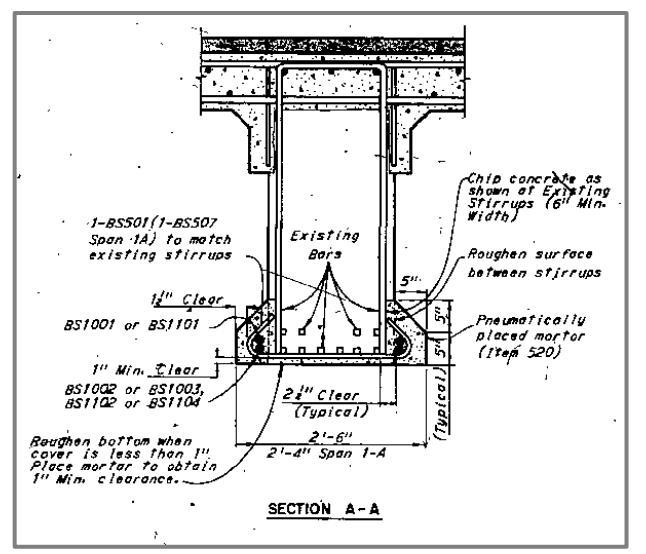
Figure 13 – Typical cross section showing floorbeam bottom flange strengthening detail during 1965 Rehabilitation.

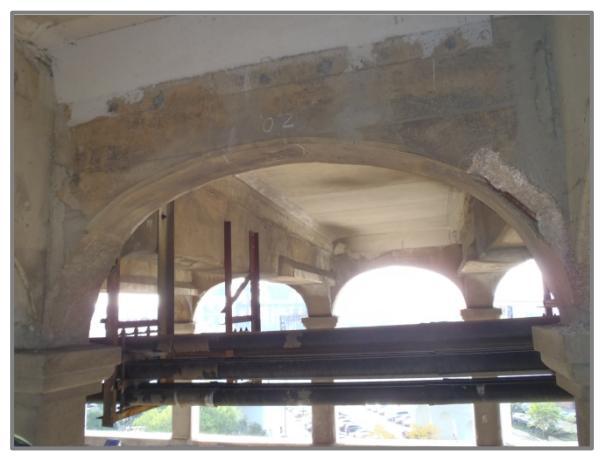
Photo 12 – Typical jack arch north elevation (Span 9 jack arch line C between Floorbeams 12 and 13).

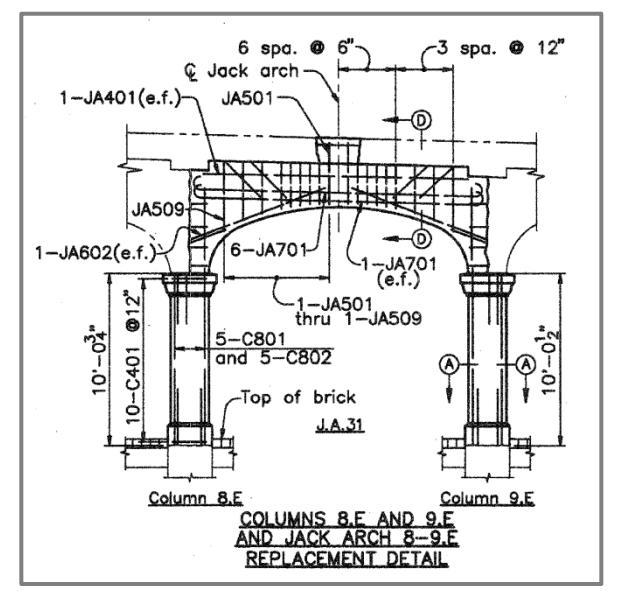
Overall the condition coding of the concrete jack arches is controlled by elements in the west approach station and tunnel sections of the bridge, which were not included in the scope of this load rating. Isolated jack arches in the remaining concrete spans exhibit spalls with exposed reinforcing and delaminated areas. In locations with exposed reinforcing, the steel typically exhibits negligible or no section loss (see Photo 13). Therefore, the capacities are not affected, and the as-inspected rating factors are equal to the as-built. Isolated jack arches throughout the structure have either been patched or replaced during the various rehabilitations of the structure (see Figure 15).

Figure 15 – Typical concrete jack arch replacement detail from 1994 Rehabilitation, showing overall geometry and steel reinforcement.

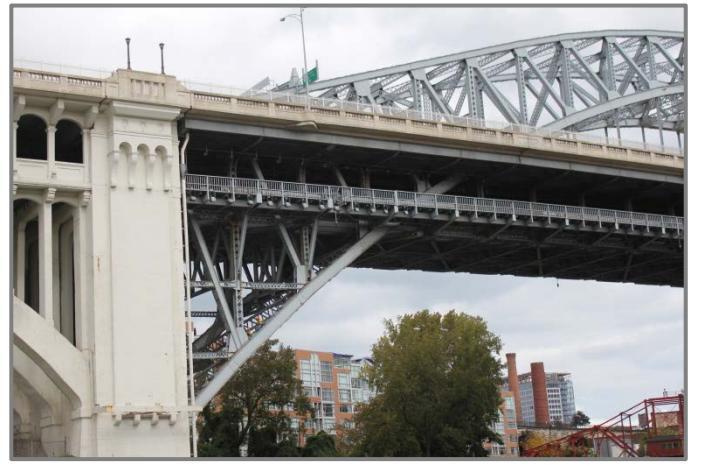
Photo 14 – South elevation of west half of Span 4. Note that Panel Points 0 to 3 are framed directly into the truss, while Panel Points farther east are suspended.

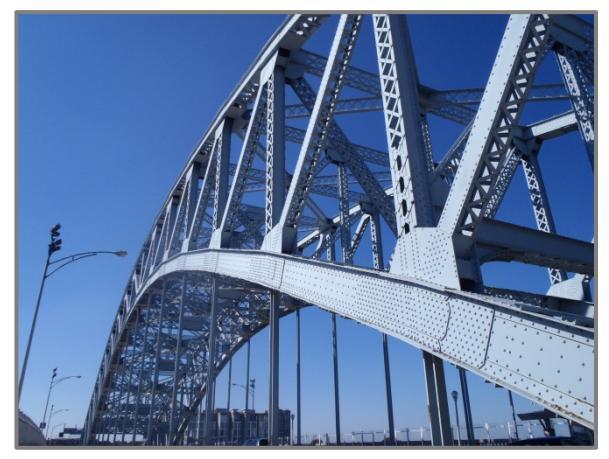
In the as-inspected condition, 17 out of 194 truss members exhibited more than 5% section loss, three locations exhibited between 10% and 20% section loss, and one vertical member (L3-U3 South) exhibited over 20% section loss. Significant deterioration was noted primarily in lower chord and web members below the upper deck level, as well as gusset plates. The controlling lower chord losses typically occur on the interior faces web plates along internal diaphragms or gusset plate edges (see Photo 15). Many of the internal diaphragms and stay plates at these locations exhibit isolated areas of 100% section loss. Upper chord members and lower chord members above the main deck typically exhibit minimal or no section loss (see Photo 16).

Photo 16 – General view of South Truss above the main deck, looking northwest.

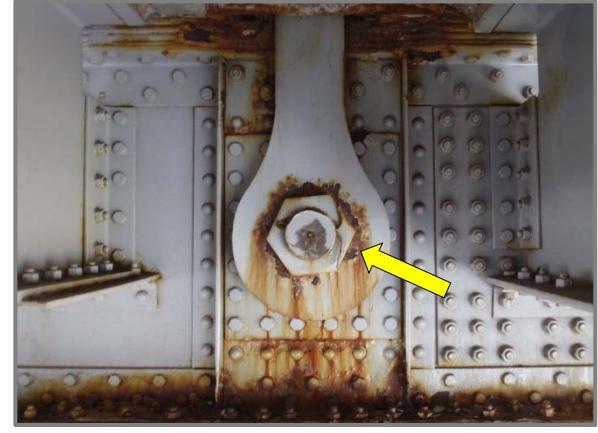
Photo 17 – East face of eyebar at connection to north lower pin at Panel Point 17.

The pins and hangers were rated with consideration of section losses noted during the inspection. Active corrosion was noted at the majority of lower pin locations and on isolated eyebar heads and shanks (see Photos 17 and 18), although section loss at most of these locations was negligible. In order to account for the corrosion at these locations, a conservative level of section loss (1/16") was applied to both faces of all eyebars and around the circumference of all lower pins, unless more significant section loss was specifically noted.

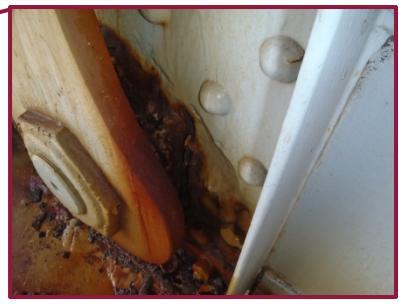
Photo 18 – East lower eyebar connection at L4 North. Note active corrosion in area and up to 3/8" pitting on pin plate.

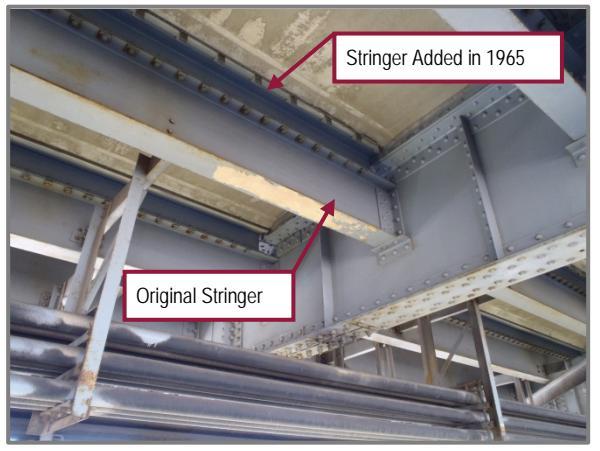
The main span steel framing has undergone a series of modifications since original construction. The entire upper framing system was either modified or replaced during the 1965 Rehabilitation, including isolated locations where the original stringer was retained and a new, smaller rolled section was bolted to the top flange (see Photo 19). The second major rehabilitation occurred in 1994, which included full removal and replacement of the top concrete deck. In addition, numerous upper framing elements were modified at this time, including full replacement of Floorbeams 5 and 19, as well as several stringers. The lower framing system also received modifications during the 1994 Rehabilitation, including four floorbeams and all of the stringers in 6 of the 24 bays.

Photo 19 – Typical stringer configuration showing original stringer and additional stringer bolted to top flange.

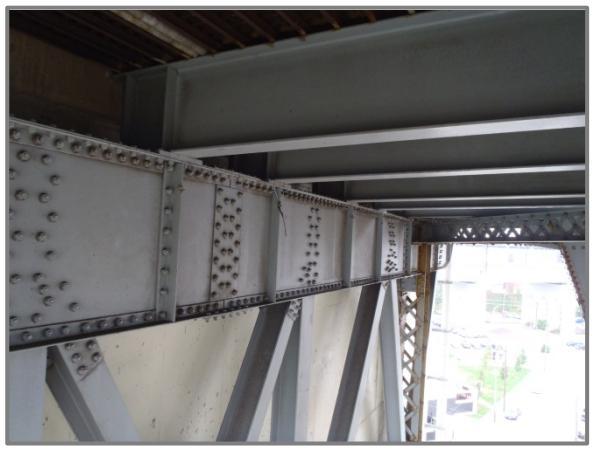
The lower deck is no longer used for regular vehicular traffic and has been converted into a multifunctional space for the City of Cleveland. Accordingly, rather than rate the lower framing members for live load vehicles, rating factors were developed for pedestrian loading only. A modified rating factor equation was used, which treats the pedestrian load as a dead loading rather than a live load. Floorbeams were modeled as continuous through the truss lines, and the last three floorbeams at each end were modeled like a truss due to presence of truss sway bracing members that frame into the floorbeams at intermediate support points (see Photo 23).

Photo 23 – West elevation of Lower Floorbeam 24. Note truss sway bracing which frames into the floorbeam between web plates.

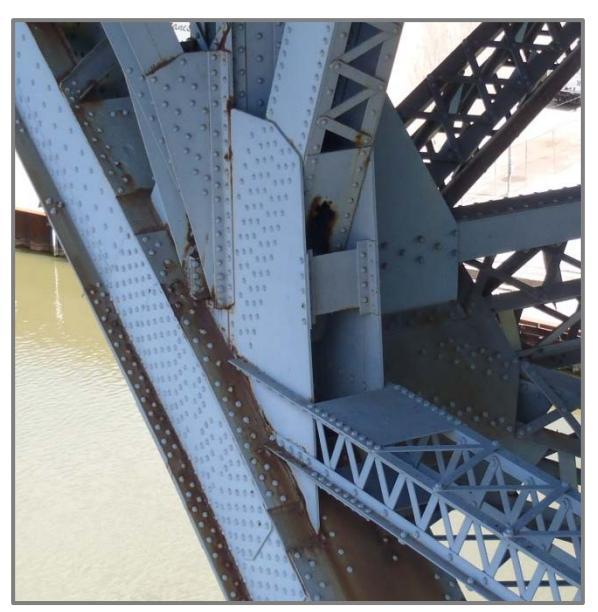
Photo 25 – Typical lower chord gusset plate connection (L2 North shown).

Chord members typically connect to the gusset plate outboard face while diagonal and vertical members connect to the inboard face (see Photo 25). Chord members terminating at gusset plates are also connected by additional web and flange splice plates.

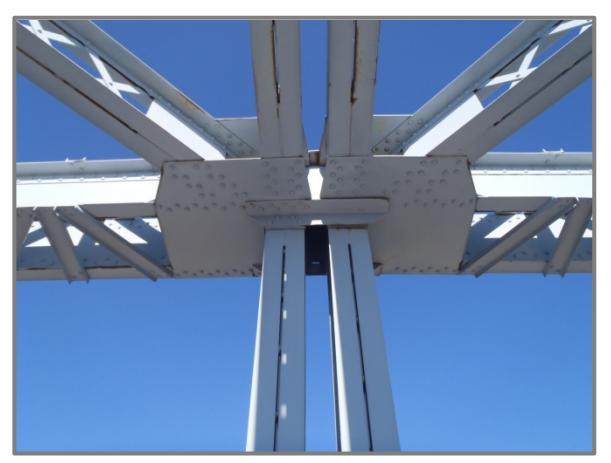
No gusset plate is present at U12, which connects zero force members with a sliding plate connection (see Photo 26).

Photo 26 – U12 Panel Point on the North Truss with zero force member restraint, looking north.
