**ANALYSIS OF BROWNFIELD CLEANUP
ALTERNATIVES (ABCA) &
REMEDIAL ACTION PLAN (RAP)**

The Park Synagogue Complex
3300 Mayfield Road
Cleveland Heights, Cuyahoga County, Ohio 44118

July 2023

PREPARED BY
BJAAM Environmental, Inc. P.O. Box 523, 472 Elm Ridge Avenue Canal Fulton, Ohio 44614 Phone #: 330-854-5300 Fax #: 330-854-5340 BJAAM Job #: 121115

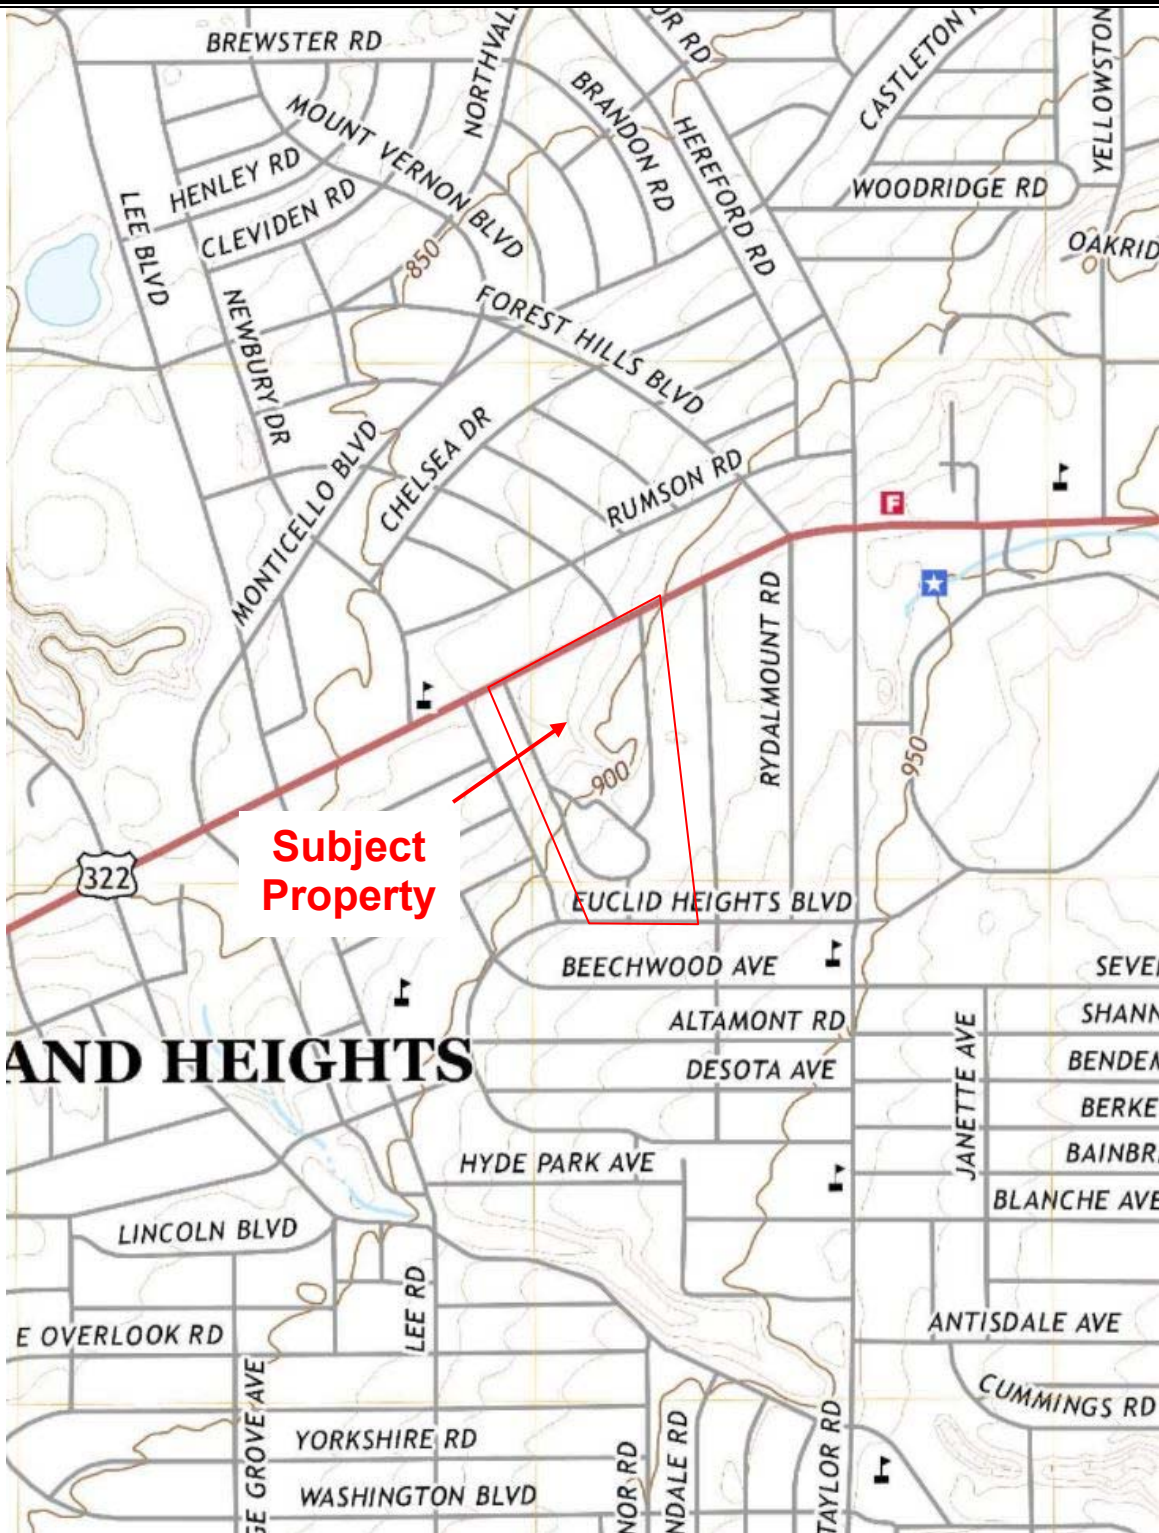
Figure
2

Topographic Map
 The Park Synagogue Complex
 3300 Mayfield Road
 Cleveland Heights, Cuyahoga County, Ohio 44118

Figure 2: Topographic Map

This Analysis of Brownfield Cleanup Alternatives (ABCA) and Remedial Action Plan (RAP) was prepared for Friends of Mendelsohn by BJAAM for The Park Synagogue Complex. Based on observations made during the Phase I ESA site reconnaissance and a review of the 2016 7.5-minute series Cleveland South Quadrangle, partially excerpted as Figure 2, topography at the Subject Property exhibits a down-gradient slope to the west by northwest and is situated at an elevation of approximately 900-feet above mean sea level (amsl).

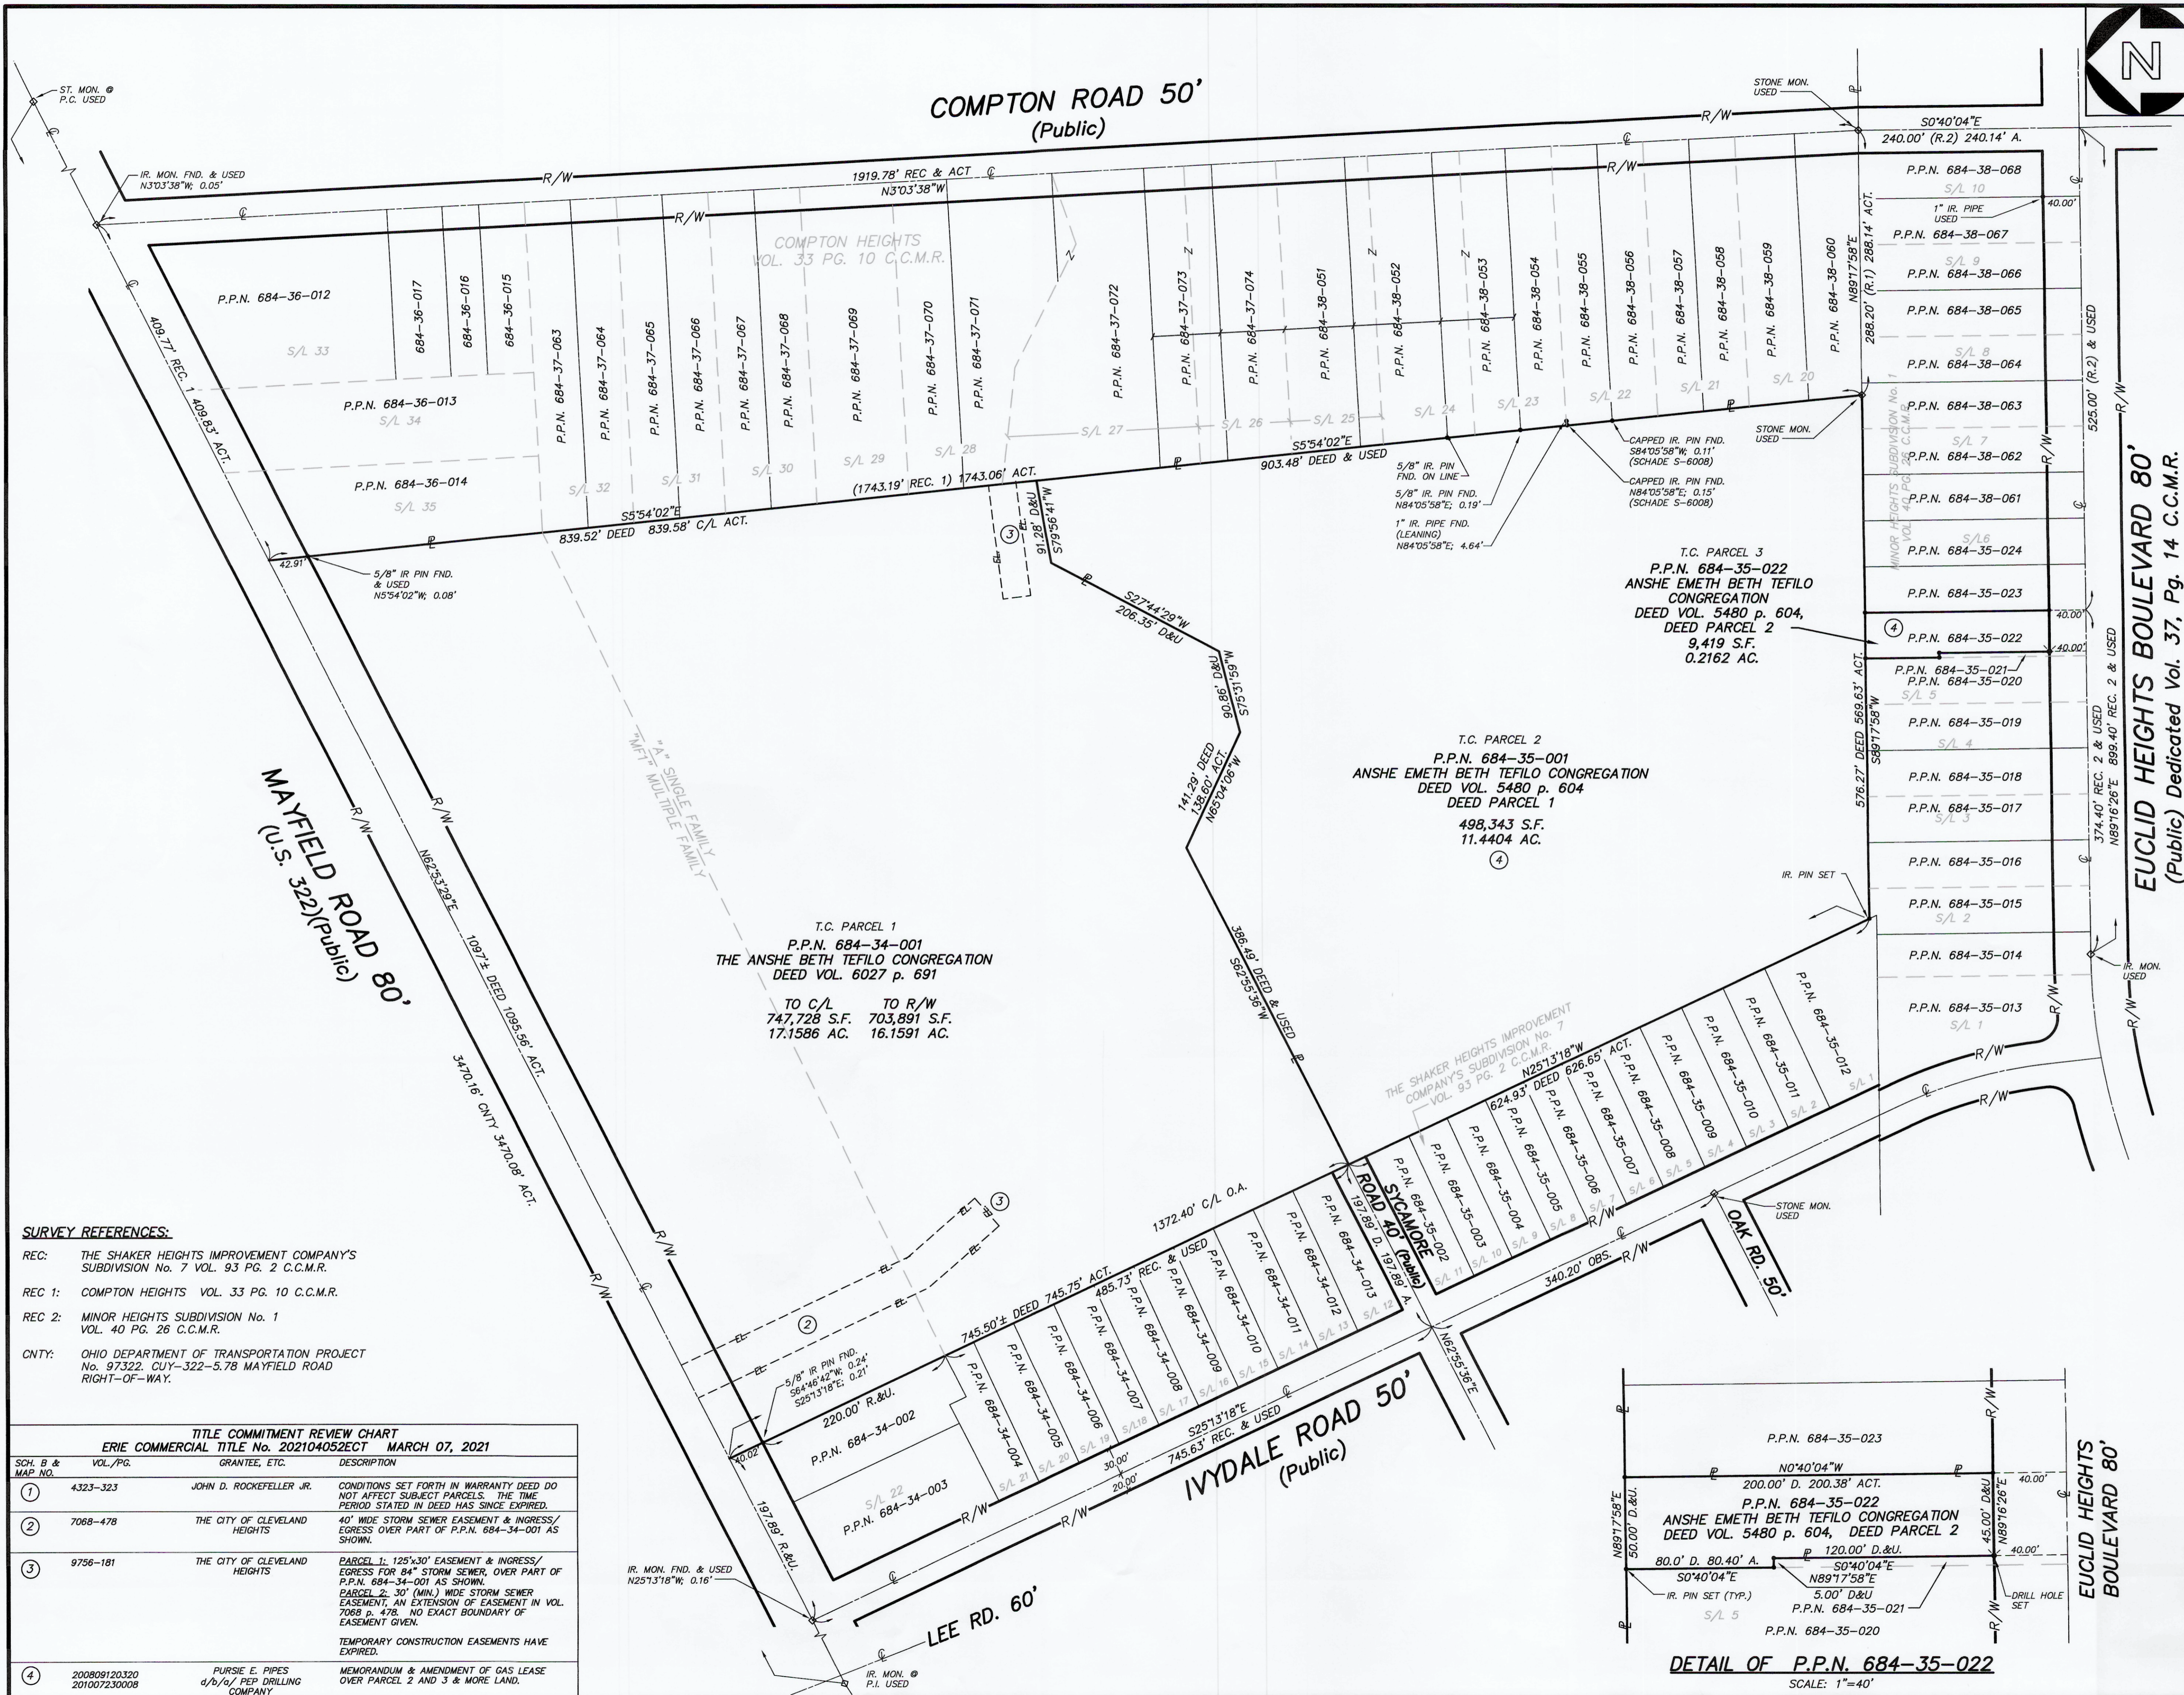
- 9) CURRENTLY THERE ARE 289 REGULAR PARKING SPACES, 21 HANDICAPPED SPACES & 49 BUS PARKING SPACES ON SUBJECT PARCELS.
- 16) NO EVIDENCE OF RECENT EARTH MOVING WORK, BUILDING CONSTRUCTION, OR BUILDING ADDITIONS OBSERVED.
- 17) NO INFORMATION ON PROPOSED CHANGES IN STREET RIGHT-OF-WAY LINES. NO EVIDENCE OF RECENT STREET OR SIDEWALK CONSTRUCTION OR REPAIRS
- 18) NO DELINEATED WETLANDS OBSERVED ON SITE.

HORIZ. SCALE 1"=40'	DRN. OGD. M.D. M.A.	DATE JUNE, 2021	2 3
GR. SCALE 0' 20' 40'	FILE NO. 522200SV	ORDER NO. 5222

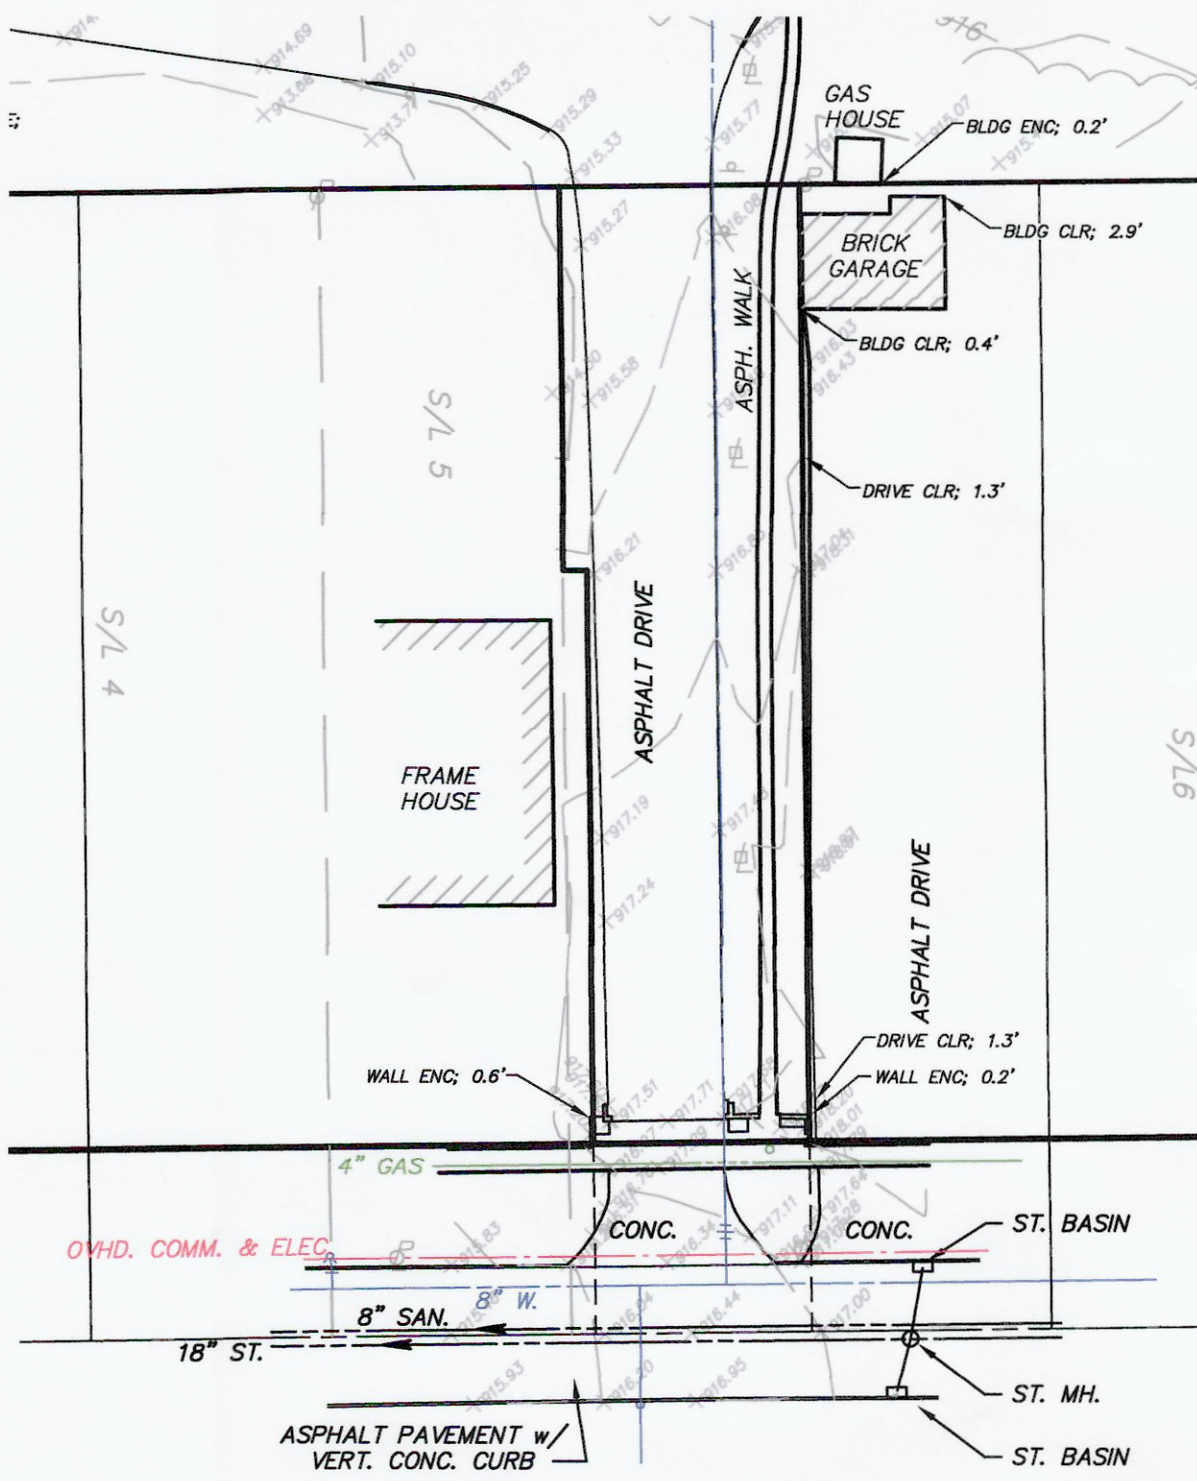
NOTES:
1. UNDERGROUND UTILITIES ARE SHOWN BASED UPON ACTUAL LOCATIONS OF ABOVE GROUND STRUCTURES AND RECORDS OF OTHERS AS TO UNDERGROUND LOCATIONS, SIZES, AND CONFIGURATIONS.
